#### LOCAL GOVERNMENT OFFICIAL INFORMATION AND MEETINGS ACT Request: 2023-42

#### CDC PLAYGROUND REVIEW STRUCTURAL ASSESSMENT AND STRENGTHENING

## PLAYSAFE AUDIT REPORT 2023

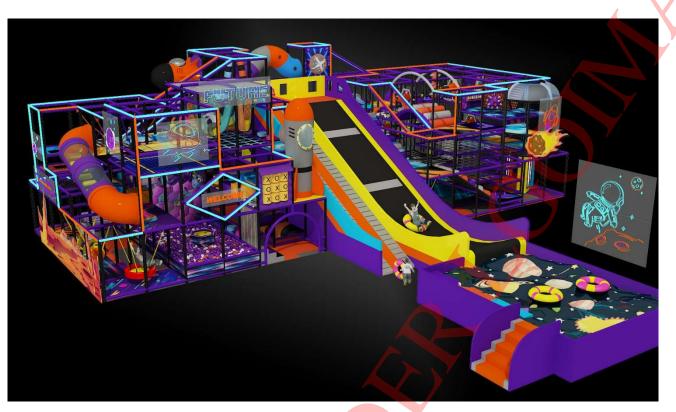
Figure 3. Playground Layout

The equipment structure for the Large Playground as shown in Figure 3 comprises of:

- A circular hollow section (CHS) 48 mm x 2 mm for framing structures.
- The hollow section members are assembled using heavy duty clamps which are tightened via heavy duty clamp set screw.
- The equipment structures are not bolted to the ground and hence will not resist uplift due to lateral loading.
- The clamped beam-column joints will not resist moments and hence the beams are designed as simply supported.
- The vertical loading from the user will be transferred to columns as compression.
- As per manufacturer's certification, the barrier or safety netting has been tested for the lateral loading from the user.

EQUIPMENT	COMMENTS	RECOMMENDATIONS
Large Playground	• The overall structure does not satisfy the lateral load criteria as per NZS 5828:2015.	<ul> <li>Add 9mm plywood in both transverse and longitudinal direction as shown in the attached sketch to satisfy the lateral load requirements</li> </ul>
Donut Slide	<ul> <li>The SHS columns and beams are able to resist the user loads as per NZS5828:2015.</li> <li>The 16mm thick plywood will resist lateral capacity as per NZS5828:2015 and NZS1170.5:2004.</li> </ul>	• No rectification required
Trampoline	<ul> <li>The trampoline structures are not sufficient for the user loading as per NZS5828:2015.</li> <li>The existing structural arrangement are not designed to resist lateral loadings as per NZS5828:2015.</li> </ul>	<ul> <li>Add 9mm plywood in both transverse and longitudinal direction as shown in the attached sketch to satisfy the lateral and vertical load requirements</li> </ul>

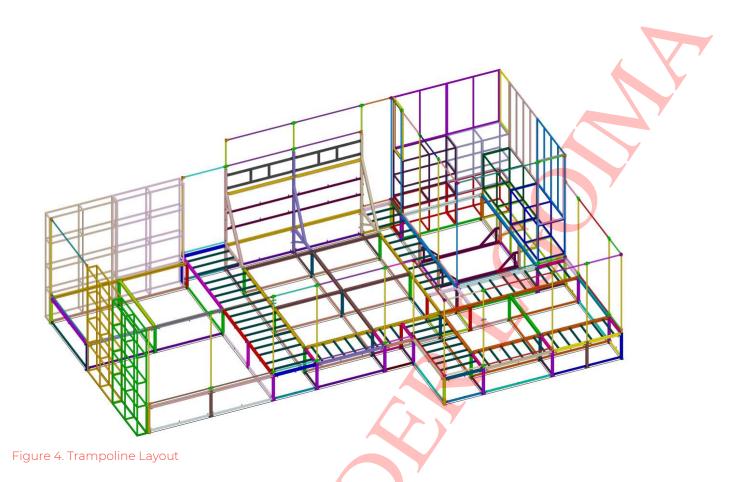
The equipment structure for the Trampoline Area as shown in Figure 4 comprises of:

- A square hollow section (SHS) 80 mm x 80 mm and presumably (SHS) 40 mm x 40 mm.
- SHS 40 mm x 40 mm are bolted to columns (SHS 80 mm x 80 mm) and welded to hollow sections in both transverse and horizontal directions.
- The frames are not bolted to the ground slab and hence will not resist uplift due to lateral loading.
- The vertical loading from the user will be resisted by the smaller hollow sections which in turn will transfer the loading to SHS 80 mm x 80 mm.

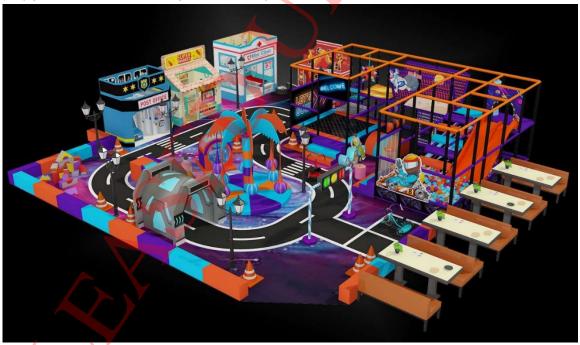
Figure 5. Toddler Playground Layout

The equipment structure for the Toddler playground is similar in arrangement to the large playground as shown in Figure 5.

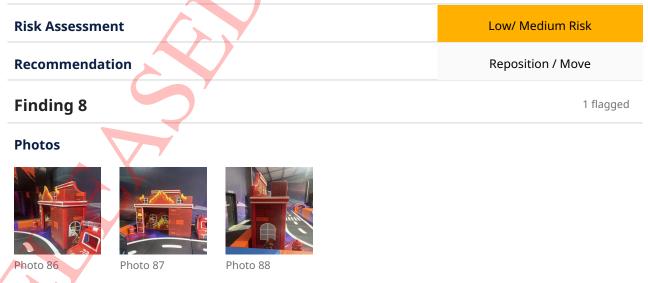
Inadequate Lighting within play equipment. Good visibility is essential to the safety management of fully enclosed play equipment. Effective supervision and monitoring are dependent upon it and fire risk assessment research has shown it is important for successful search and rescue. As per NZS 5828:2015 Part 10. The lighting used should give a good colour rendering of all surfaces and avoid glare or pools of light and shade inside the facility. Insufficient lighting encourages vandalism fires etc.

Hidden enclosure with no supervision line of sight and insufficient natural light encourages vandalism fires etc.

Some blind spots exist in the under 5's area - recommend the dark voids that are not well lit behind the village are addressed (i.e blocked), these are undesirable gaps that are difficult to supervise.

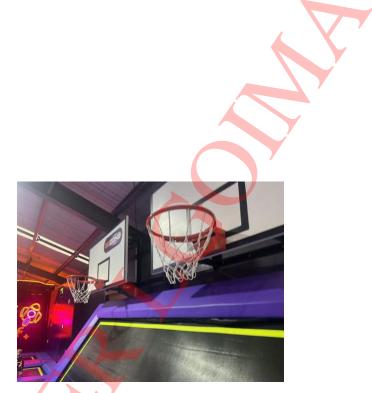
Roof Potential head and neck entrapment - Fails Probe C & D (Torso, then Large Head) between 89-230mm. The gap does not meet the requirements of head & neck entrapment as per NZS 5828:2015 Part 1 >600mm FHF. (Requirement is less than <89mm or greater than >230mm dia)

# **Risk Assessment** Recommendation Rectify Finding 21 1 flagged **Photos** Photo 136 Photo 134 Photo 135 Activity Ноор All exposed bolt threads should Issue be cut off and bolt heads / nuts

cap covered as per NZS:5828:2015 Part 1. Missing fastenings - Replace. Low/ Medium Risk **Risk Assessment** Recommendation Rectify Finding 22

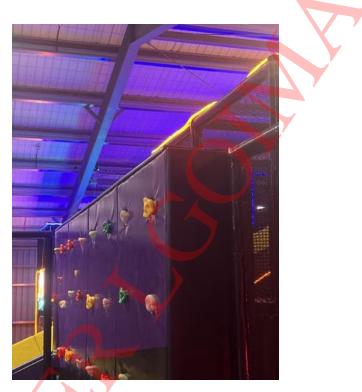
I would suggest some tows of rocks are removed and/or a reverse return is added to eliminate the possibility of climbing ontop.

Risk Assessment	High Risk (Close ASAP)
Recommendation	Rectify
Finding 25	
Photos	
Photo 147 Photo 148	
Activity	Trampoline
	Fence Panel
GoZone Wairarapa / Indoor Play Area Private & confidential   Playsafe Ltd   www.playsafe.co.nz   info@playsafe.co.nz	32/106
