LOCAL GOVERNMENT OFFICIAL INFORMATION AND MEETINGS ACT Request: 2024-57

I draw your attention to document 6, a report prepared by Calibre Consulting Limited in July 2021. The report reviews the footpath, and driveway angles and refreshes the flood risk assessment of Lincoln Road following the completion of the road resurfacing. This report does not appear to have been released previously.

Report

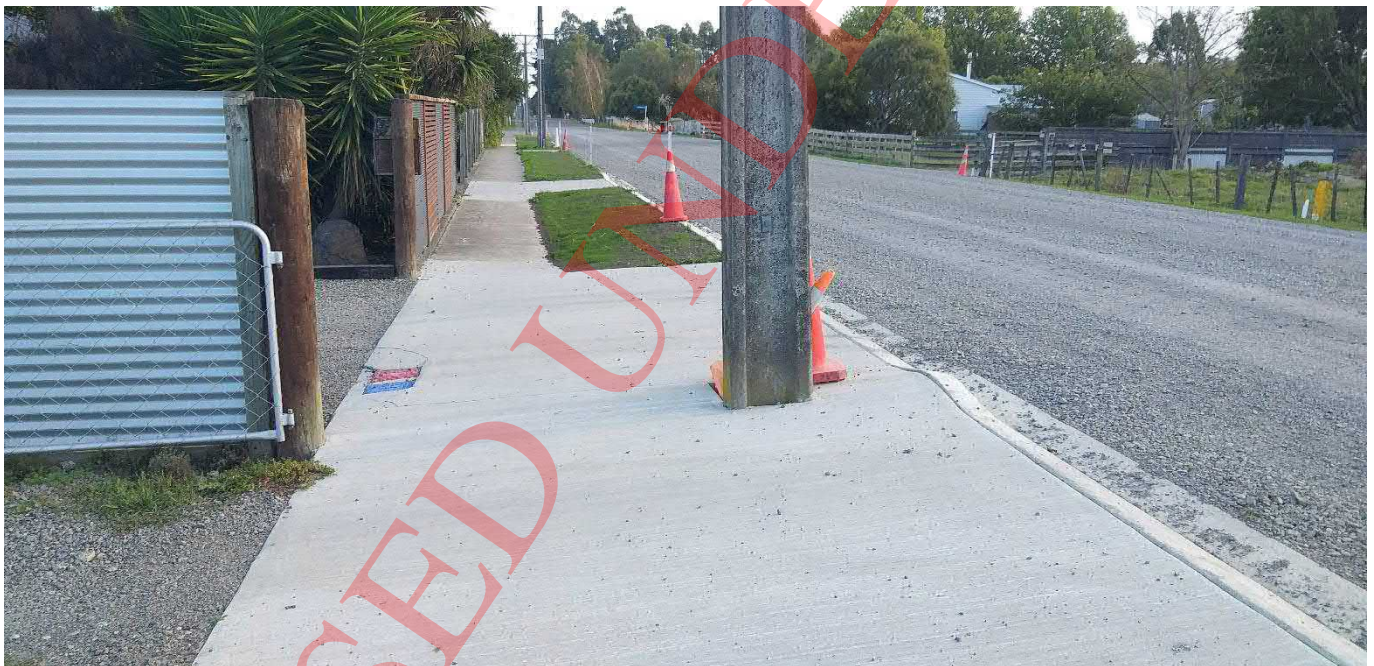
Photograph - The above photograph shows the driveways falling back into properties. This can result in surface water flows entering properties from the footpath, and surface water from within the properties being unable to flow out. The net result is likely to be localised flooding at the property entrances.

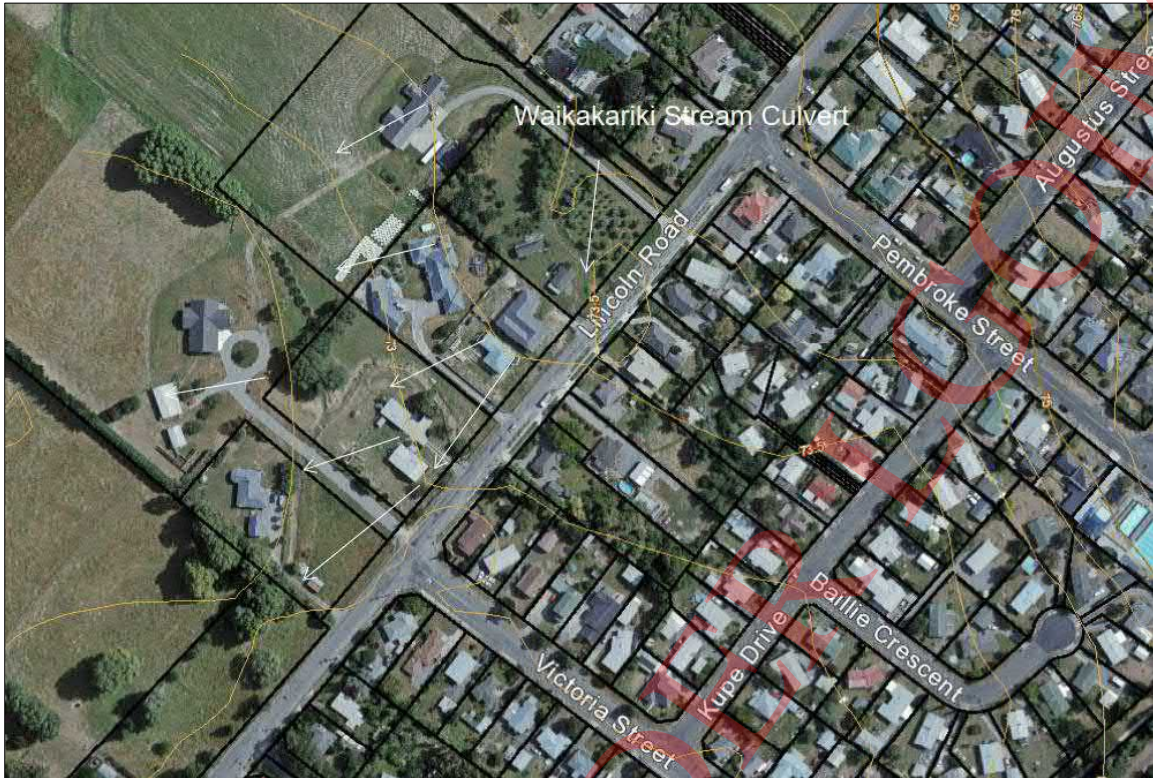
Flowpaths for Floodwater from the Culvert Near No. 42 Lincoln Road

The contours, show that there is a "basin" at the entrance to the culvert, roughly defined by the contour line of elevation 73.5 metres. In a flood event and if the culvert is blocked, or where the storm event exceeds the capacity of the culvert, the basin will overtop, and floodwater will spread out across the adjoining land. This floodwater will take the preferential flowpath, that is, it will travel down slope at right angles to the contours of the land. The white arrows shown on the aerial photograph are perpendicular to the contour lines and indicate the preferential flowpaths for floodwaters.

In general and based on the contours shown on the aerial photograph, it can be expected that floodwaters will spread out south-westward and follow the contours of the land toward the Waikakariki Stream.

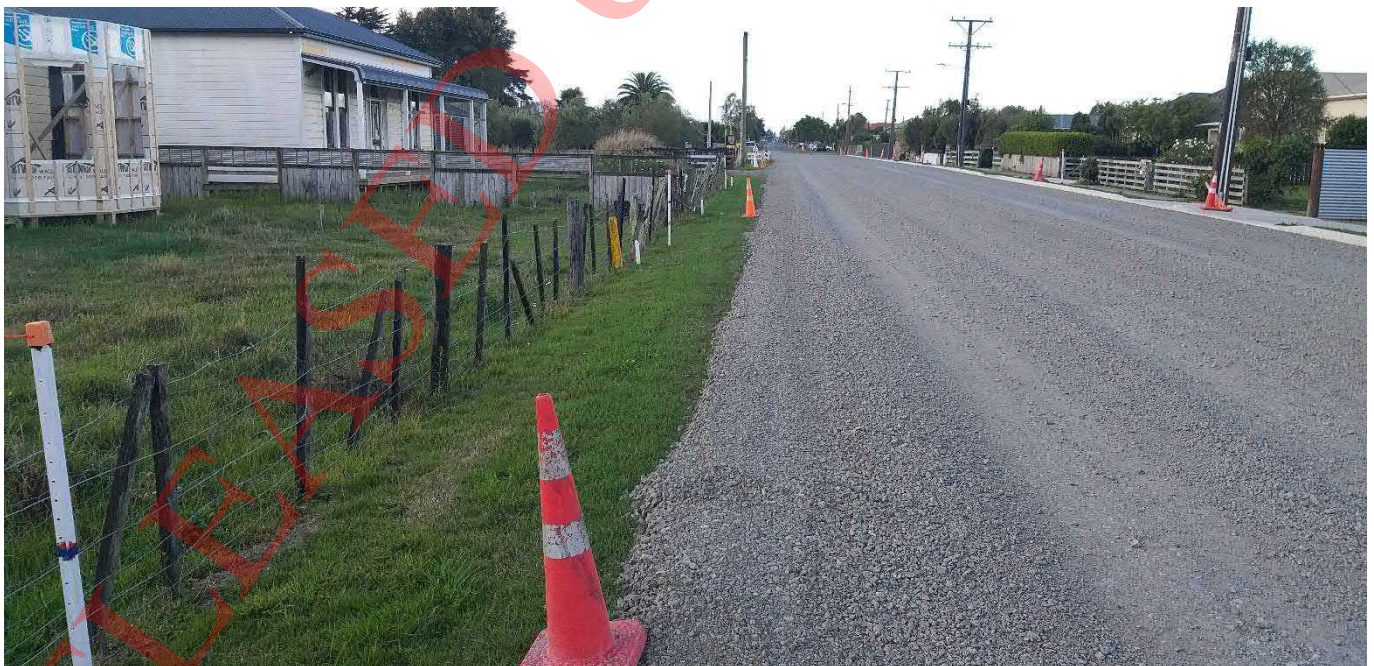
Photograph - The swale drain/table drain referred to above is evident along the current fenceline. Further south of this location it enters undulating land and is not visible.

Some of the floodwater from a blockage of the culvert would follow the route of the swale drain/table drain southwards toward the Waikakariki Stream. Localised flooding would occur due to the undulating nature of the ground and due to raised driveways that cross the flood route.

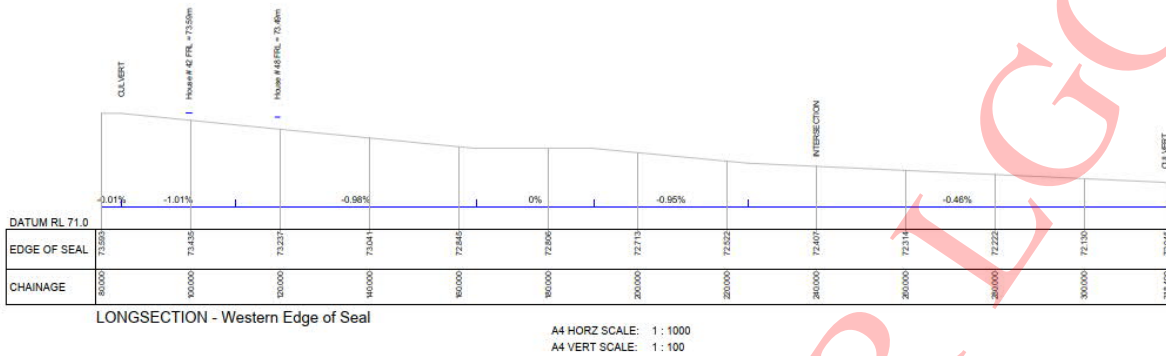
Detail 1 - Longsection of the Western Side of Lincoln Road from North to South

The grey line shows the edge of seal, approximately 150mm above adjoining property levels, and the short blue dashes the relative heights of the floor levels of No.'s 42 and 48 Lincoln Road in relation to the edge of seal.
