Report

Lincoln Road Flood Risk Assessment

Prepared for Carterton District Council

2 July 2021

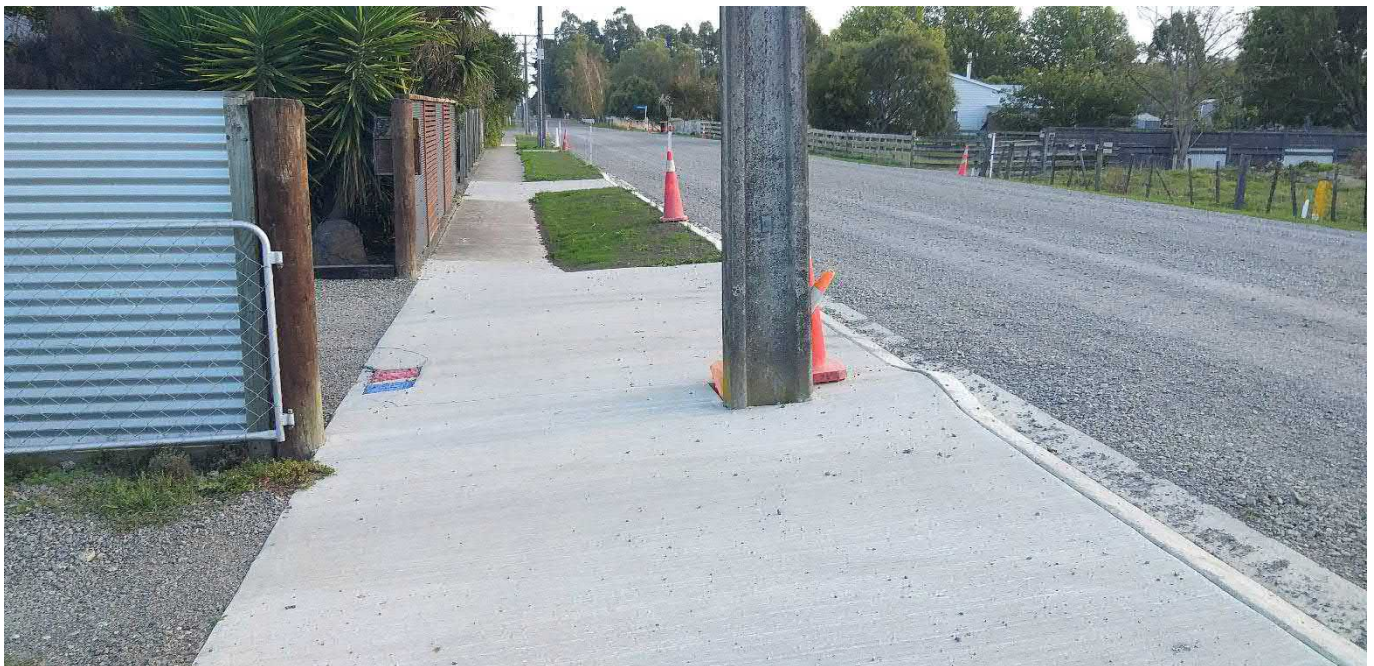
Photograph - The above photograph shows the driveways falling back into properties. This can result in surface water flows entering properties from the footpath, and surface water from within the properties being unable to flow out. The net result is likely to be localised flooding at the property entrances.

There is currently no outlet for surface water trapped in these valleys so there is a potential for localised flooding.

In the event of prolonged rainfall leading to overtopping of these valleys, the relative heights of the adjoining property boundaries and concrete driveways will determine the flowpath for this surface water. Where the property boundaries are above the height of the driveway, water will flow over the driveway and into the next valley, potentially exacerbating the problem further downstream. Where the driveways are above the level of the property boundaries surface water will overtop the boundary and flow into private property.

In summary the *Removal and Reconstruction of Driveways* is the recommended option, noting that a topographical survey will be required to provide sufficient information for the detailed design.

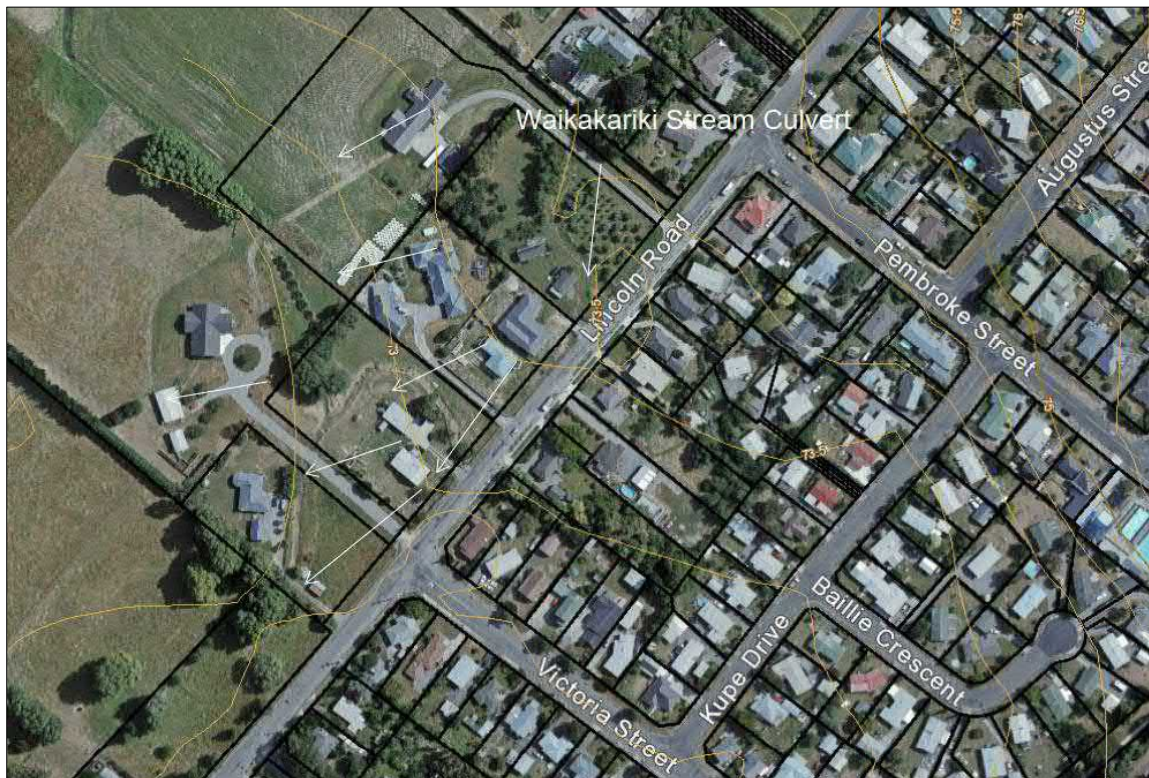
Flowpaths for Floodwater from the Culvert Near No. 42 Lincoln Road

The contours, show that there is a "basin" at the entrance to the culvert, roughly defined by the contour line of elevation 73.5 metres. In a flood event and if the culvert is blocked, or where the storm event exceeds the capacity of the culvert, the basin will overtop, and floodwater will spread out across the adjoining land. This floodwater will take the preferential flowpath, that is, it will travel down slope at right angles to the contours of the land. The white arrows shown on the aerial photograph are perpendicular to the contour lines and indicate the preferential flowpaths for floodwaters.

In general and based on the contours shown on the aerial photograph, it can be expected that floodwaters will spread out south-westward and follow the contours of the land toward the Waikakariki Stream.

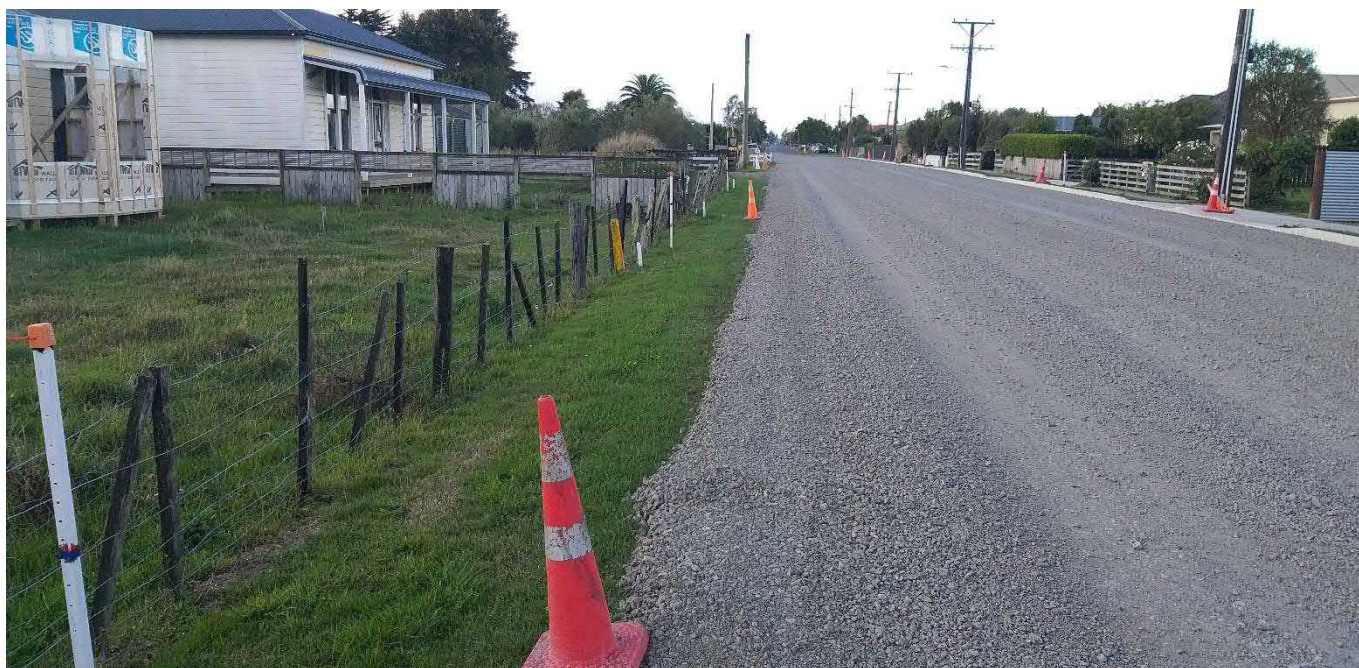
Photograph - The swale drain/table drain referred to above is evident along the current fenceline. Further south of this location it enters undulating land and is not visible.

Some of the floodwater from a blockage of the culvert would follow the route of the swale drain/table drain southwards toward the Waikakariki Stream. Localised flooding would occur due to the undulating nature of the ground and due to raised driveways that cross the flood route.

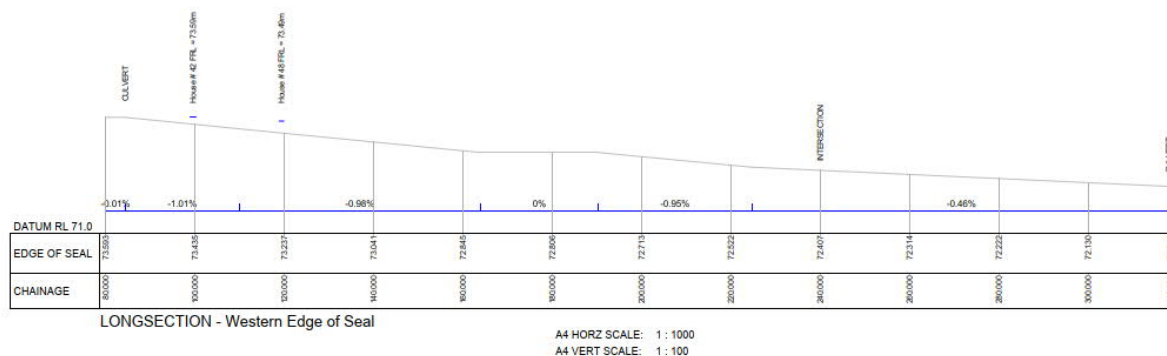
Detail 1 - Longsection of the Western Side of Lincoln Road from North to South

The grey line shows the edge of seal, approximately 150mm above adjoining property levels, and the short blue dashes the relative heights of the floor levels of No.'s 42 and 48 Lincoln Road in relation to the edge of seal.

At the right-hand end of the longsection is the ground level at the edge of the Waikakariki Stream after it crosses back to the western side of Lincoln Road, near Victoria Street. The height differential between this level and the ground level at the edge of the culvert by No. 42 Lincoln Road, assuming the shoulder height is 150mm, is approximately 1.2 metres. The crown of the road is approximately 90mm above the edge of seal.

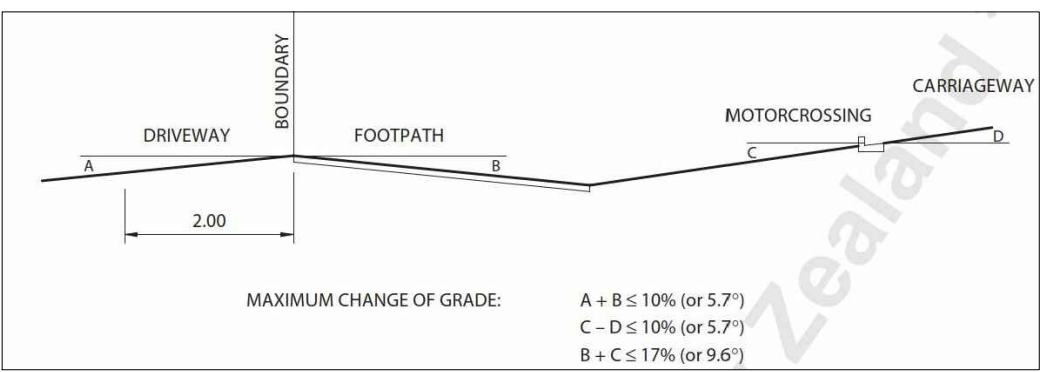
FIGURE 3.9 - MAXIMUM BREAKOVER ANGLE FOR VEHICULAR ACCESS TO PROPERTY (NZS 4404:2004)

If the changes of grade are too abrupt the front and rear sections of vehicles may scrape the concrete, or the centre sections of vehicles may bottom out. Careful analysis and reference to design guides for vehicle access to property would need to be referenced.
