January 2022

Carterton District Council-

Playground Report 2022

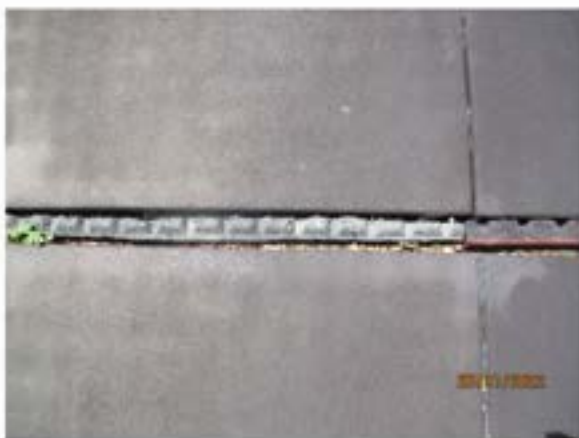
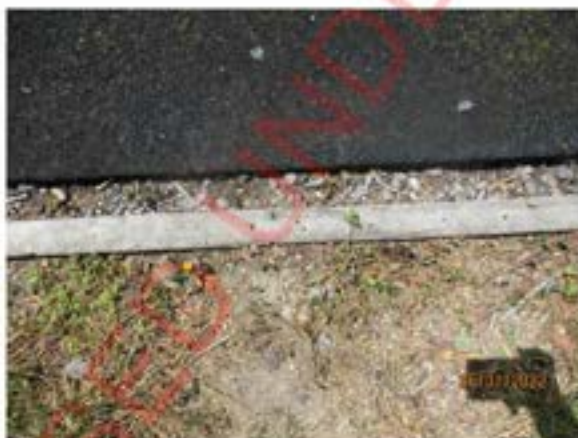
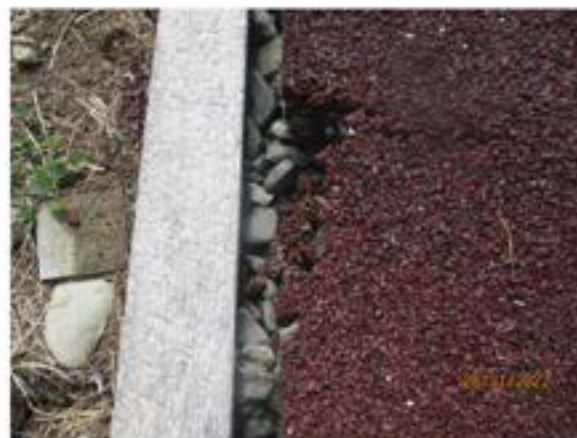
The synthetic surfaces were not wearing well. It is unclear who the supplier is for the wetpour surface but it is not wearing as well as it should be.

Much of the wetpour surface was splitting and coming away from the edges. This is a result of poor installation methodology. It is not normal for wetpour to wear in this manner.

The tiles were also lifting and coming away from the edge.

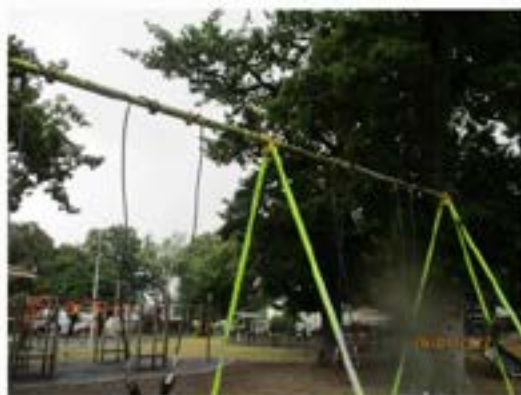
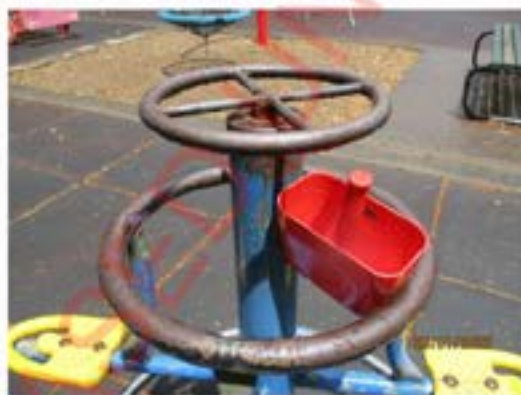
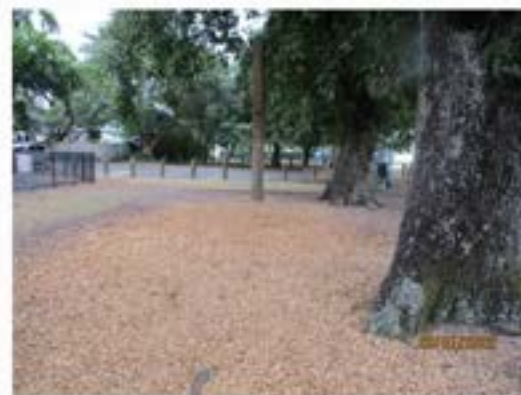
The items with a condition 4 (poor) rating and priority 2 renewal priority are:

Carrington Park is an intensively used playspace, due to the level of use needs more frequent renewal and more frequent maintenance to keep it up to specification.

Safety surface loosefill and tiles, Swings, Lullaby Swing, Mousewheel, Flying fox, South End Park Turnstyle

These items could undergo major renewal or be replaced. As there are such a high number of items at the one location, consideration should be given to a holistic renewal. Review the entire playspace.

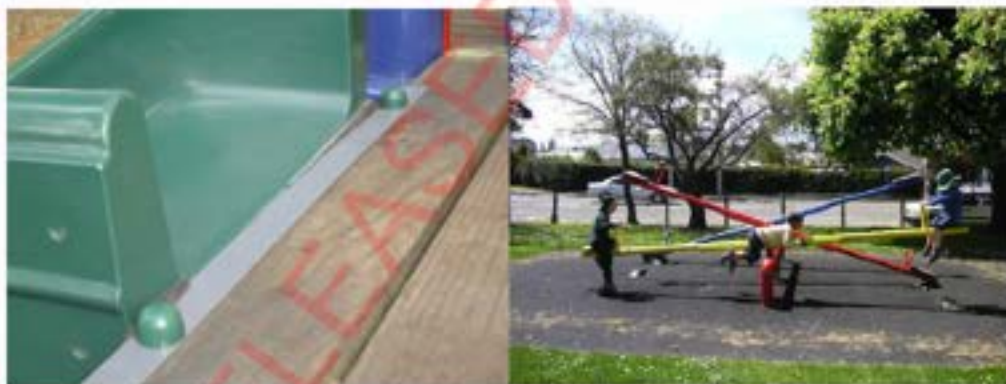
A number of slides had toggle entrapments at the top of slides. The combination of timbers meeting plastic or stainless slides and the movement of the materials through heat and cold causes gaps to form. The gaps need to be regularly filled. The entrapment of clothing toggles and consequent strangulation has caused the highest rate of deaths on play equipment worldwide. This issue is not clearly identified in the previous New Zealand Playground Standards. The entrapment is measurable under the NZS: 58282015 standard.

Children often lie on the top middle of a seesaw, as shown in the photo. Their fingers can get entrapped in the moving mechanism. There are a number of seesaws with a loose fitting at the centre bearing allowing a gap for finger entrapments. I recommend covering the centre fitting with the rubber guard if the central fitting cannot be tightened. Cover the entire fixing so that children's fingers cannot enter the area of movement at the centre of the seesaw bearing.

Photo: slide entrapment gap and possible finger entrapments on seesaws

A toggle entrapment probe was used to measure for any entrapment gaps at the top of slides. A gap or diminishing wedge at the top of a slide may allow clothing to catch before a child descends down the slide. The entrapments are a result of poor installation methods, deck to slide design and or the movement and shifting of plastics. The maintenance contractor can successfully fill many of the slide entrapments with a line of silicone in the gap between the deck and the slide.

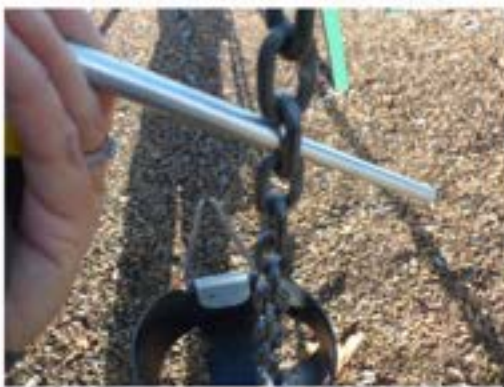
The playground standard NZS 5828:2015 identifies the size of finger entrapments in the swing suspension chain or chain connections. There are a number of cases of swing sets with non-compliant chain or connections. The standards are not retrospective so there is no requirement for these to be upgraded until the unit is renewed.

Finger entrapment in chains

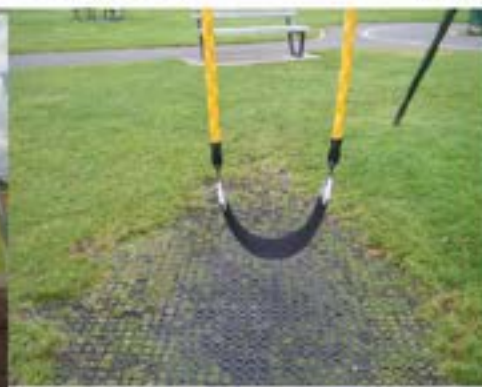
2. Provide a swing suspension member that is not made of chain.
3. Provide a cover over the chain. This method is problematic, if the chain cover splits or comes away then the chain exposes finger entrapments. Further to this chain cover constantly gets cut, is broken, and has sharp edges. The chain underneath the cover cannot be inspected for wear. We are starting to see swing chain failure as a result of chain wearing and rusting under the chain cover. The Inspector recommends only using compliant chain and not purchasing items with chain cover on them.

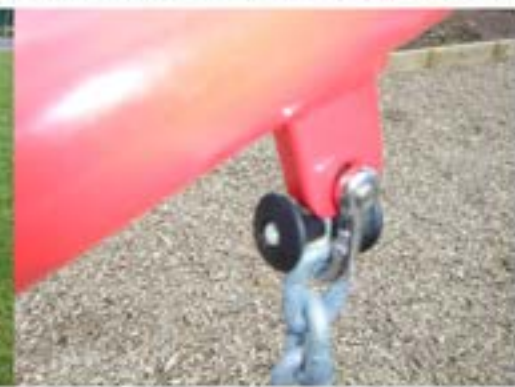
plug to fill entrapment gap in connections

4. There is a plug that can be installed on those connections that have a finger entrapment – as shown on the images
5. When swing suspensions are renewed ensure compliant chain is used.

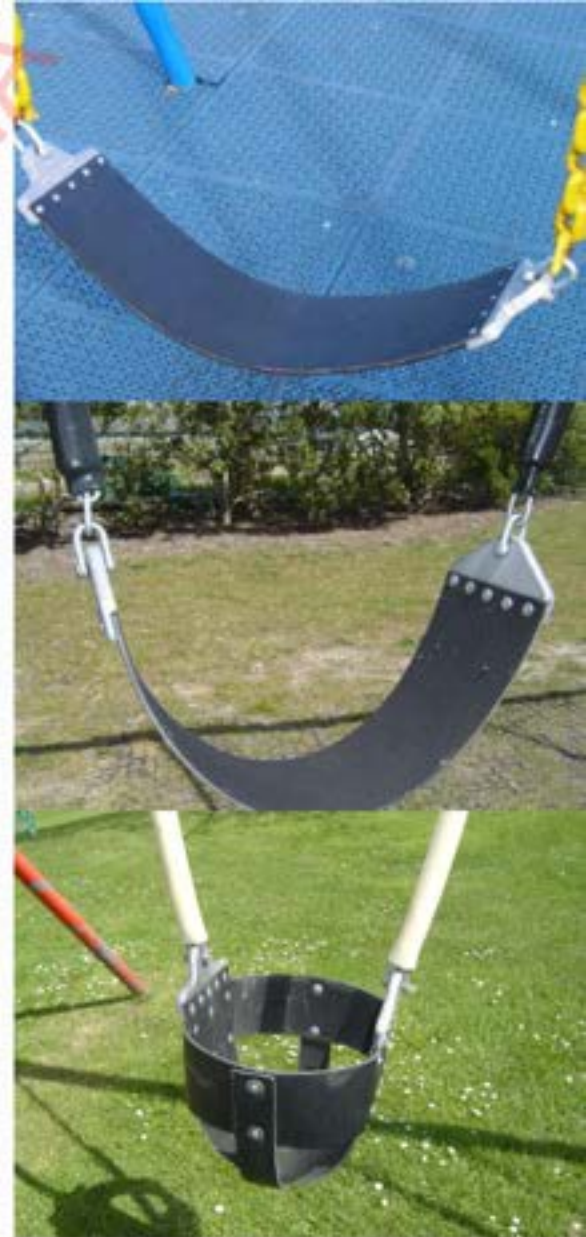
Swing seats: The type of swing seat being used by the city is wrought with problems, the metal plates lift and become sharp, the seat's rubbish perishes and allows water into the inner plate. This in turn rusts and breaks. The type of swing seat currently being used by the City requires frequent renewal. There are two alternative manufacturers in New Zealand making swing seats that have had the problems designed out of them. They get a considerable longer life out of these swing seats.

The Inspector recommends using an alternative seat to reduce maintenance replacements. A Company in Wellington is producing swing seats of a different design that does not have the problem of plates lifting. The swing seat is called 'Rubber bits' and trades under the name of Industrial conveyors Ltd, 12 Victoria Street, PO Box 30598, Petone. 04 568 6983 and fax 04 568 6536. Alternatively Dunedin District Council are making their own swing seats, and may produce them for others.

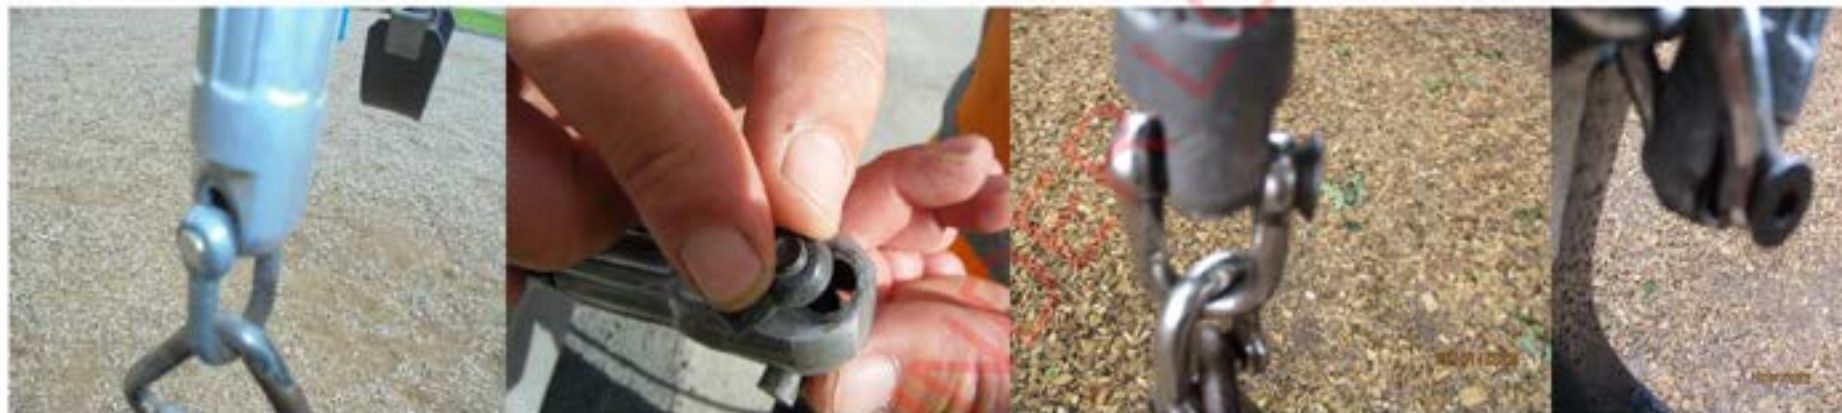
Carrington Park Swing Suspension Connections

The District has a number of the Park Supplies type of swing suspension connection. The swing connections wear and break at the lower end of connection. These swing connections need to be monitored and replaced as required.

This type of swing suspension is at **Carrington Park**.

Photo: swing connection and wear

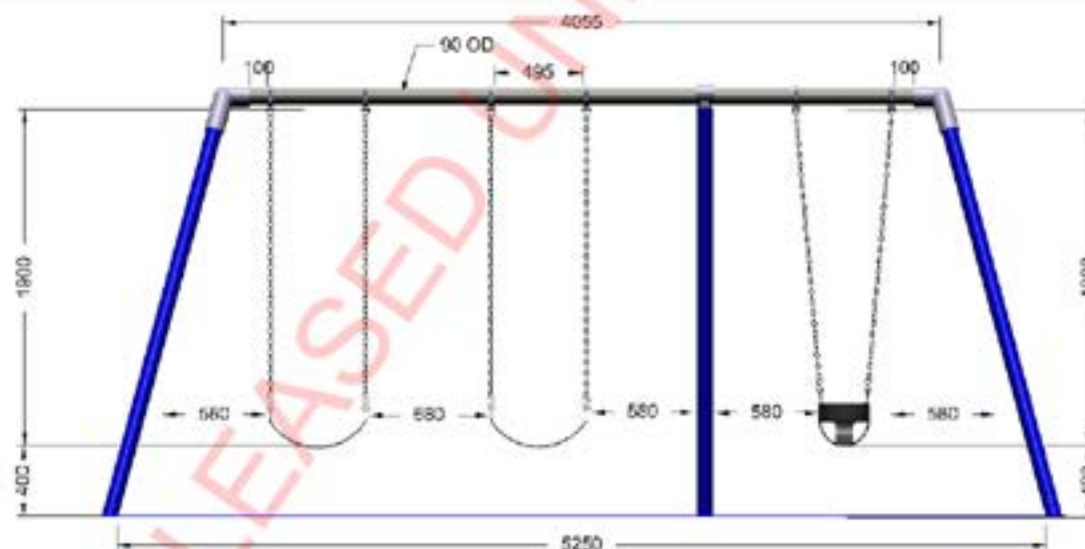
Swing seats: The height of the swing seat impacts on the compliance of the swing set. The swing seat height shall be set at the following heights:

If the swing seat is set an appropriate height it impacts on the scuff under the swing. Clearly if the seat is too low there will be a higher degree of scuff under the swing seat.

The height of the swing seat for belt type seats is measured with a load
