Preliminary Site Investigation Report

683 Dalefield Road

Carterton

31 January, 2018

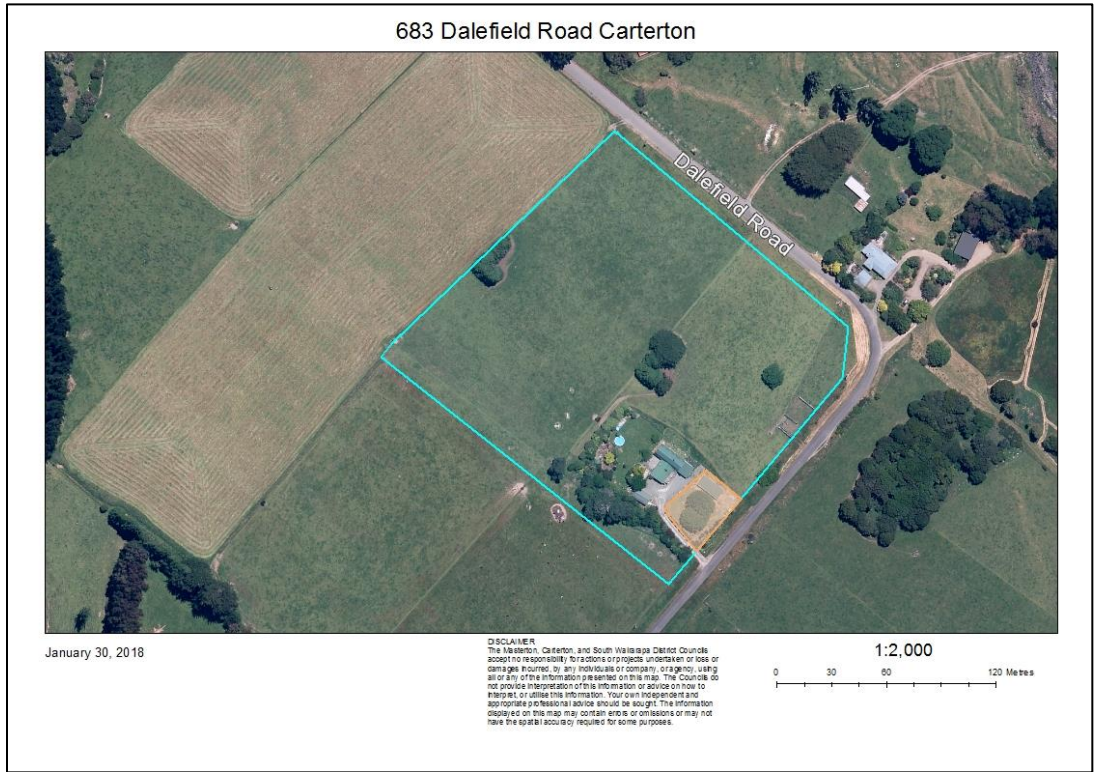
A woolshed and yards were located on a section of this property, along Dalefield Road ('the site'). The woolshed has since been removed, but the yards are still present (figure 1).

Figure 1 Location of 683 Dalefield Road, Carterton. The blue line represent the property boundary, the orange shaded area is the location of the former woolshed and yards

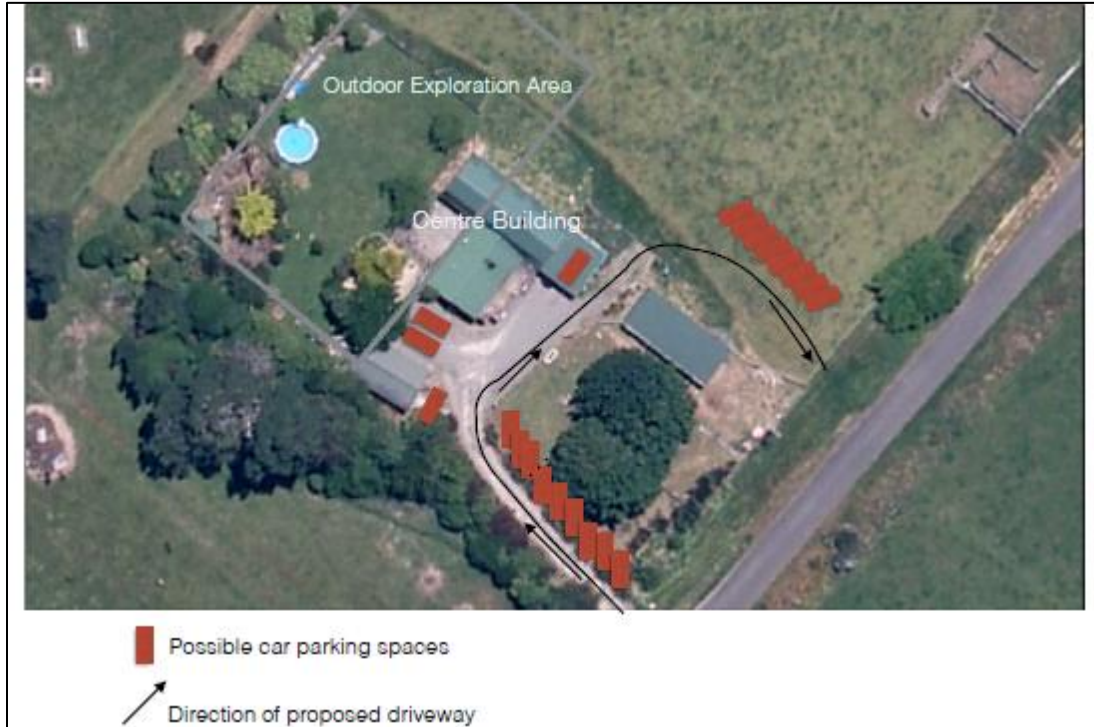
The client would like to redevelop the site as a carpark for the proposed Early Childhood Centre in the buildings adjacent to the site (figure 2).

Figure 2 Proposed outlay of the carpark for the Centre

Currently the site is fenced and access to the soil will be further reduced by planting the site with shrubs and covering the soil for the proposed carpark with a permanent cover, such as base course, concrete or asphalt.

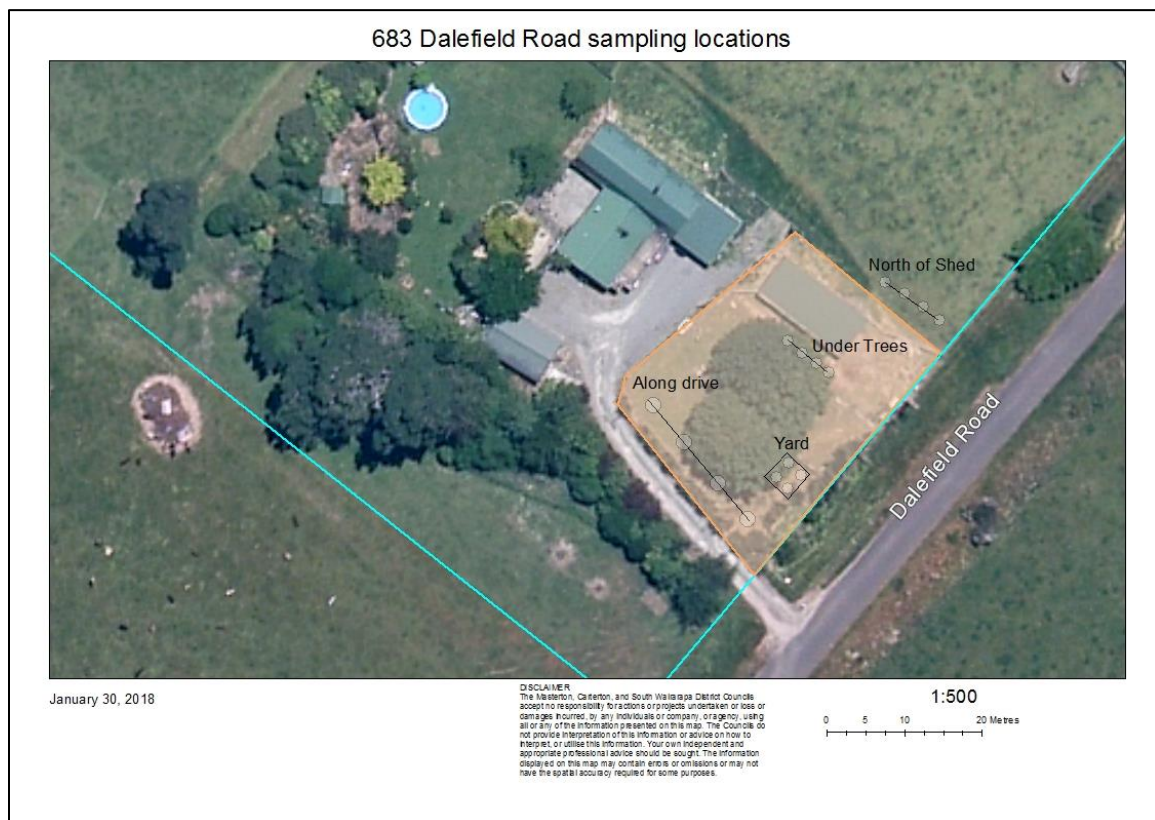
Four transects were sampled, three across the former yards and one in the area north of the current shed. Each transect contains 4 samples taken 1-2 meters apart. The 4 samples on each transect were combined to one bulk sample.

The samples were taken with a stainless steel auger from 0 -15 cm.

Figure 4 Approximate location of sampling transects at 683 Dalefield Road, Carterton

Of the four the sample transects only site 'along drive' has arsenic concentrations above 17 mg/kg (Table 3); the soil contaminant standard for rural residential, 25% produce (MfE, 2011).

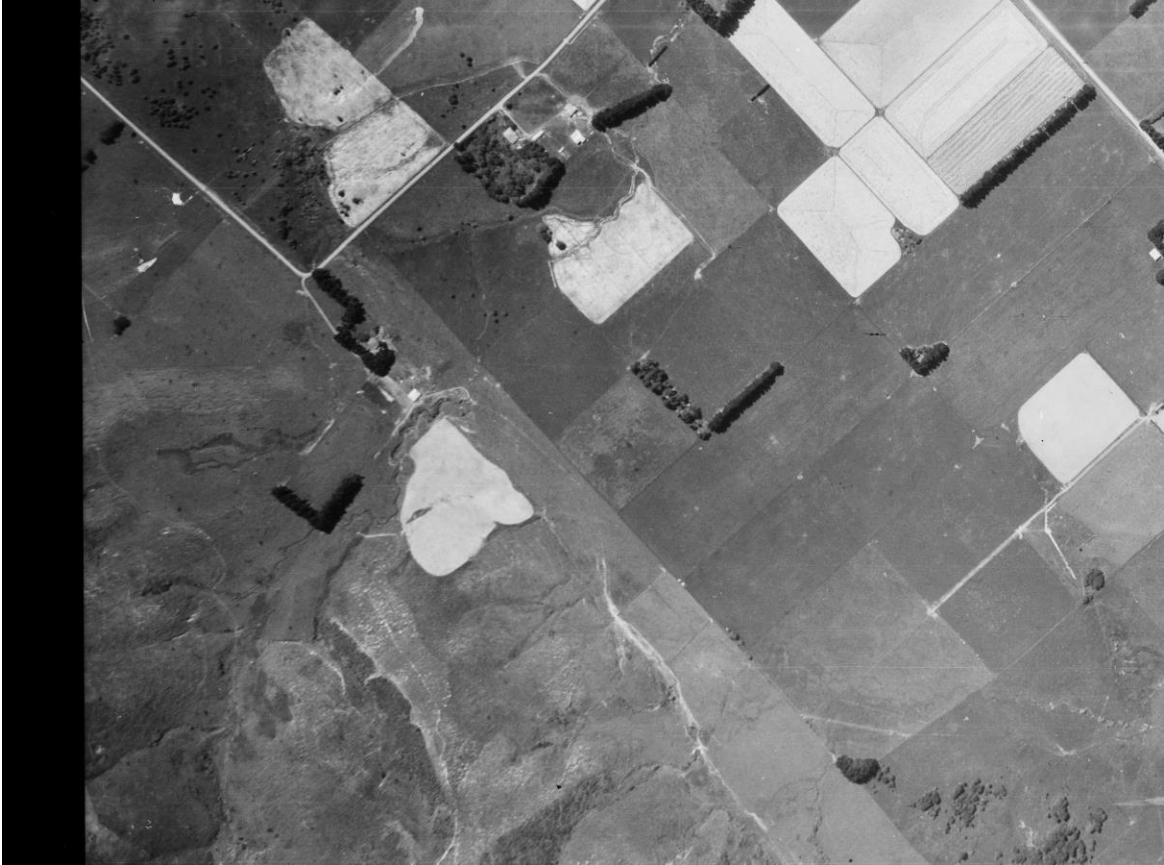
Ca 1943

c. 1943 – The earliest photograph is from 1943. This aerial photograph clearly shows that there was no shearing shed or yards on the site

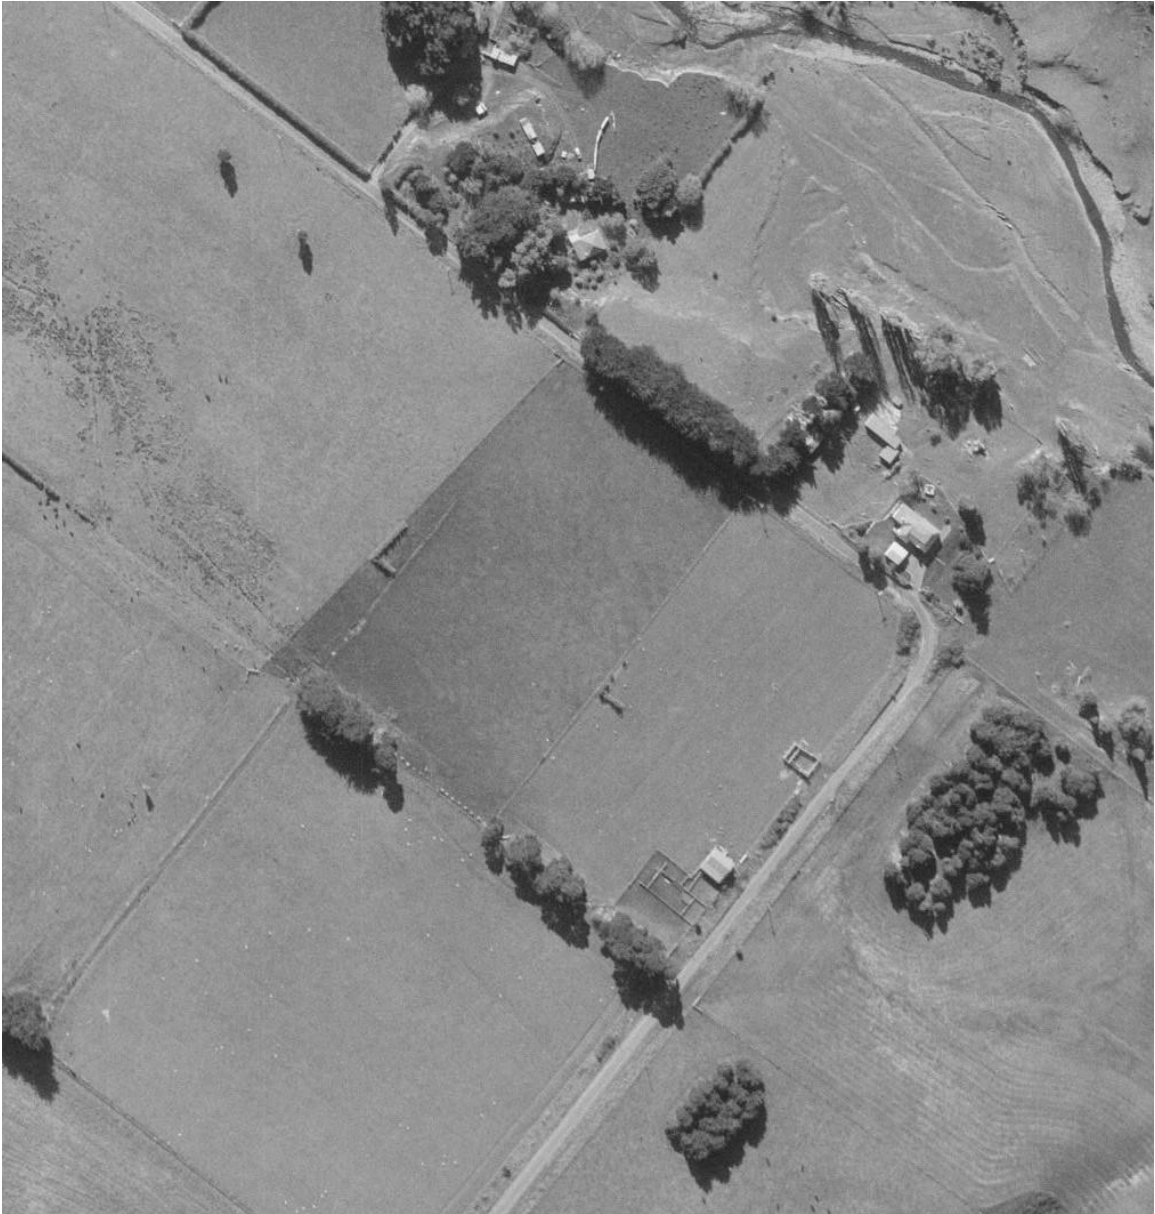
1963 – This aerial photograph shows the shed. Also visible in the photograph are a number of pens/yards. A dip bath was not visible.

There is no clear evidence that there was a sheep dip with a dip bath on the site. Aerial photographs of 1963 (Appendix B) show a yard structure attached to a woolshed.

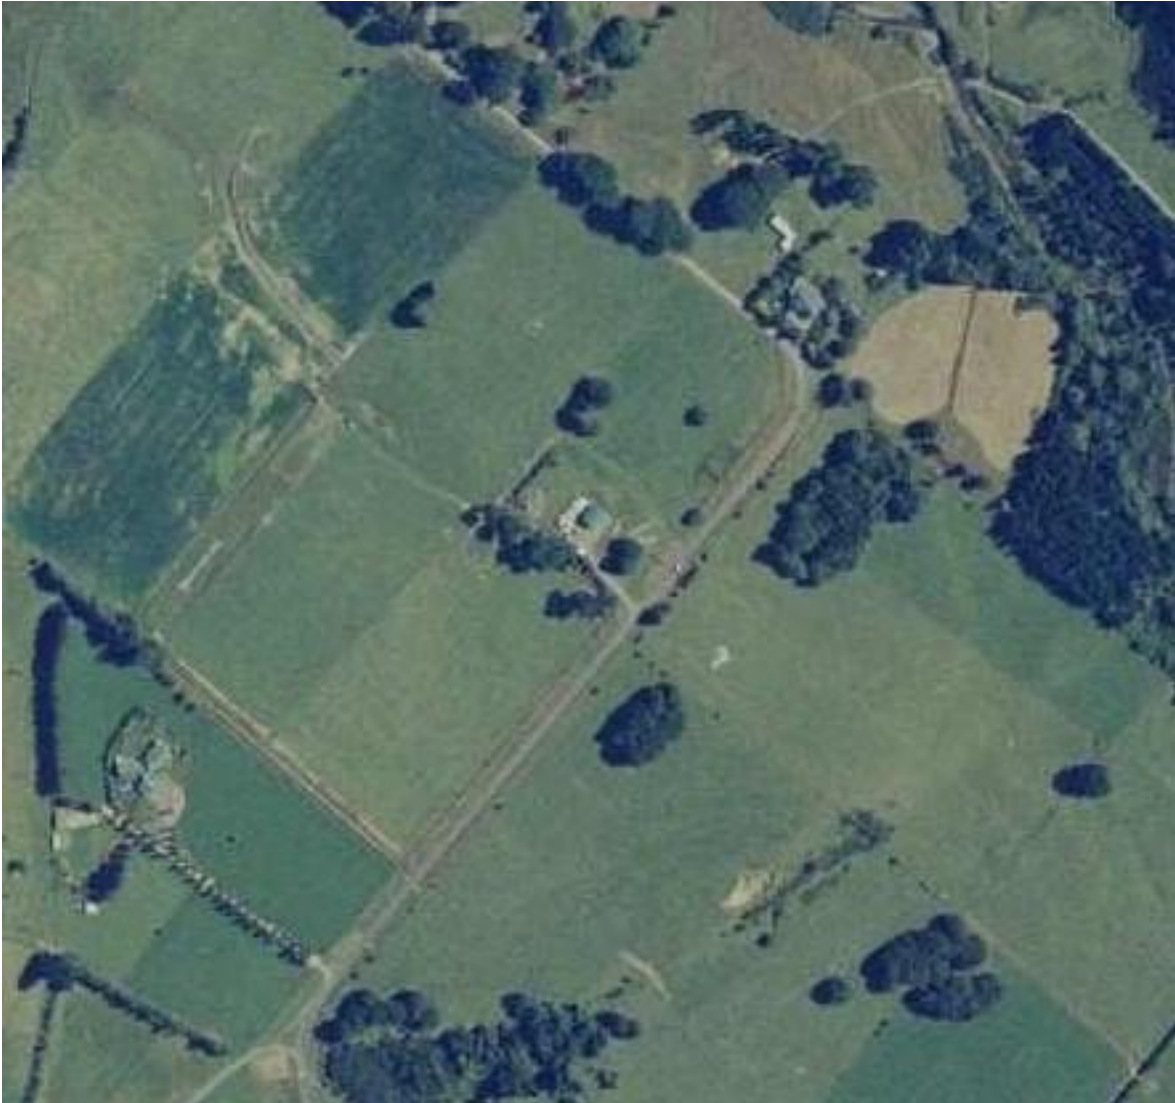
2003 – This area photograph shows that a house north of the site, but no woolshed. Mature trees are in the yards.
