**Carterton District Council
Infrastructure & Service
Committee Meeting**

Wednesday 15th March 2017

Roading Report to End February 2017

NZTA's proposed pedestrian crossing – Carterton Medical Centre

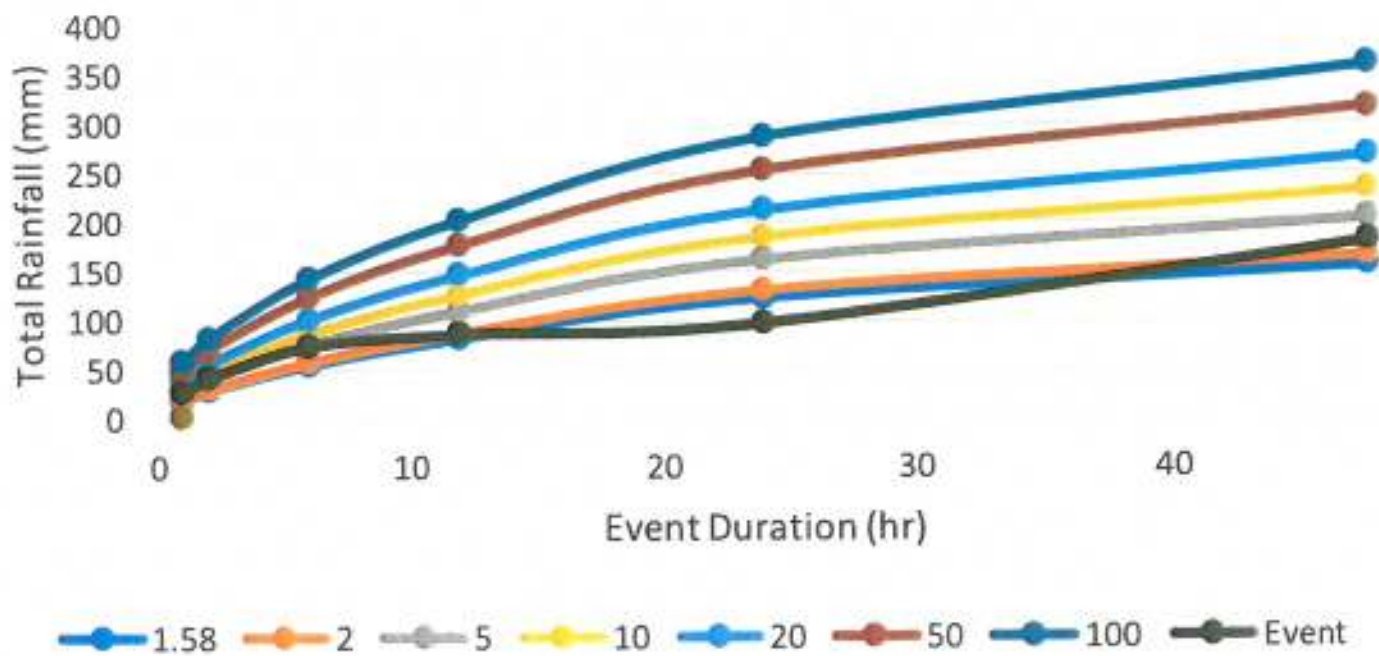
Rainfall Event 17-18 Feb 2017 Kaipatangata Catchment

The initial conclusion, then, is that it was the short term intensity which was the likely cause of the significant flow and damage, as the same event passed over NZET offices on the Saturday and the extreme short duration intensity was noticed and actually photographed as it was so heavy. The would however have been exacerbated by the fact that there was a similar event only some 20 hours prior and the ground would have had a high level of residual saturation from that prior event.

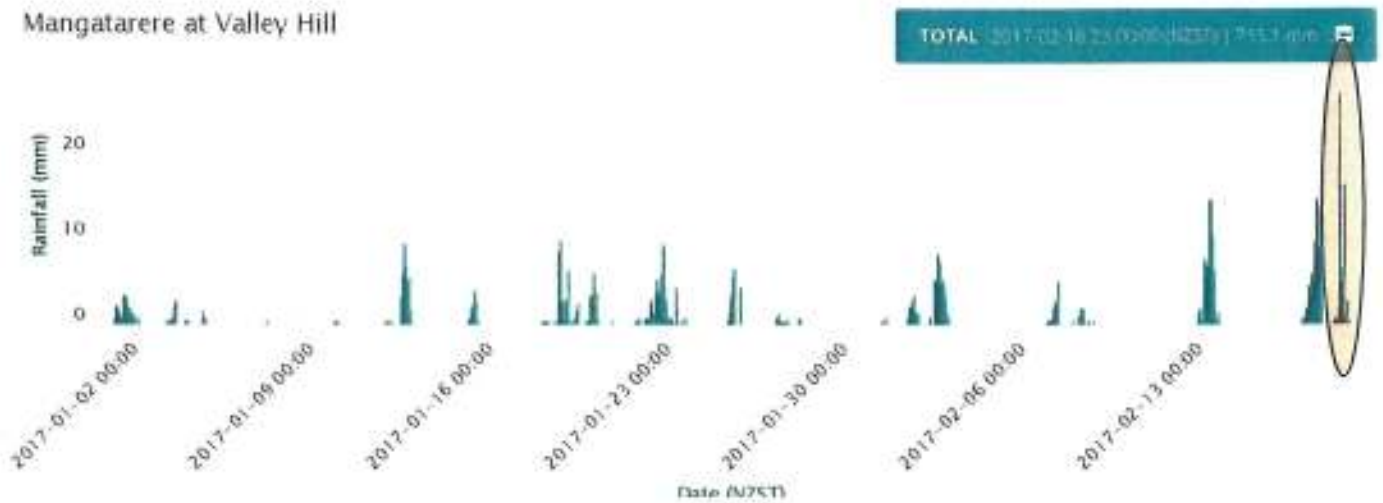
Mangatarere at Valley Hill

Inspection of the flow recorder at the Kaipatangata water treatment plant shows a flow of 2392L/s (2.3m³/s -not particularly high), was recorded at 1522 on 18 Feb and then the reading was static at that value. Assuming a flood flow velocity of 4m/s and based on the observed channel width and flood height a more realistic maximum flow at the WTP weir would have been in the order of 84m³/s. The peak flow recorded at the Mangatāre Stream at SH2 was 237m³/s of which under normal conditions, the Kaipatangata would comprise approx. 1/3. The Mangatāre Stream at the Gorge flow gauging site recorded 150m³/s at 1545 on the 18th February before its flow measuring capacity was destroyed. The Waiohine River at the gorge also recoded a maximum flow of 140m³/s at 1530 on the 18th February.

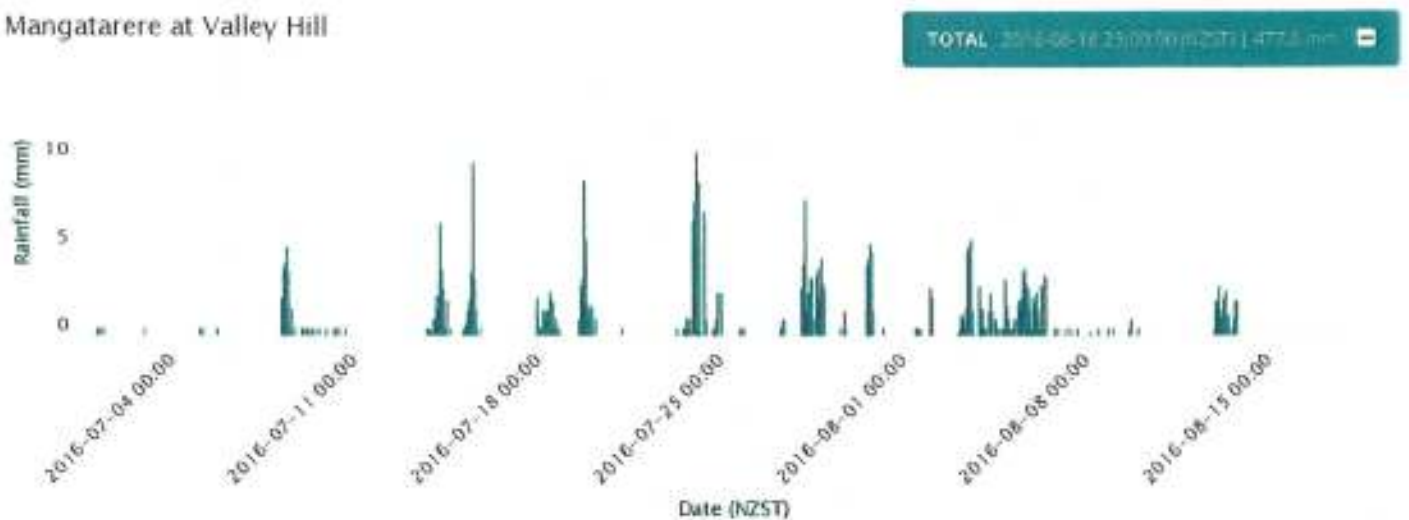
Mangatarere at Valley Hill

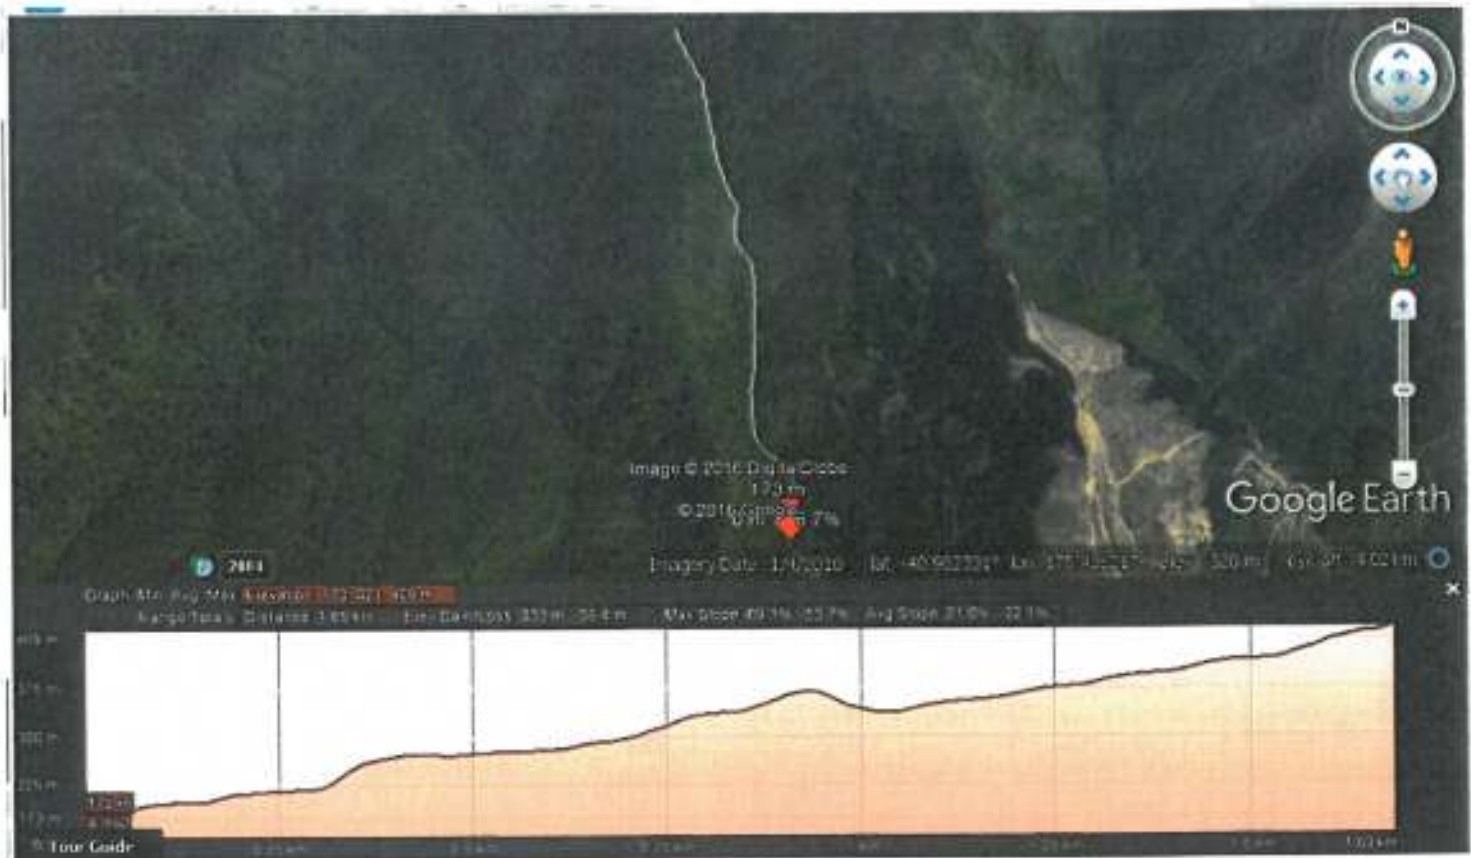
Channel length 1.69km
 Average slope 21%
 Estimated Tc 20-30min

Yet the flows and damage experienced indicate that this was an event which occurs much less frequently. Two possible explanations for this are: the rainfall history leading up to the event; or the short duration intensity (the GWRC records only log down to hourly intervals). So if the logged hourly rainfall occurred evenly over the hour, that is very different than if it occurred mainly over say a 20minute or 30minute period.

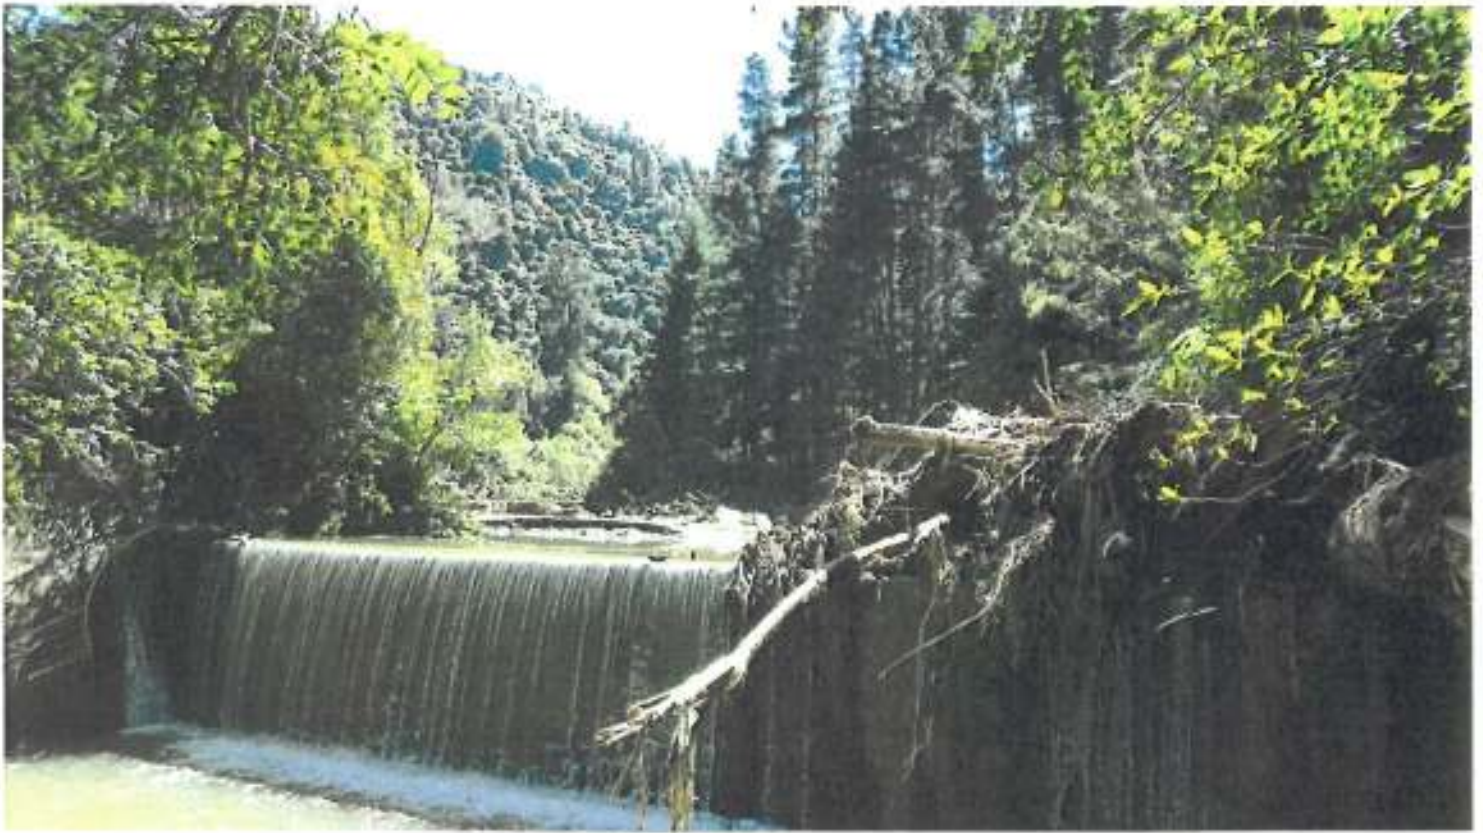
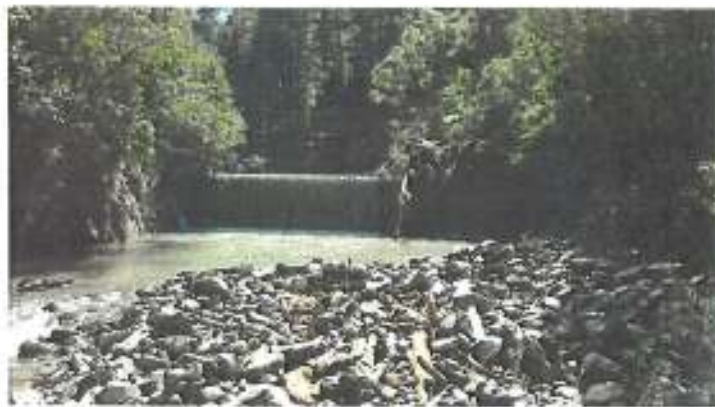
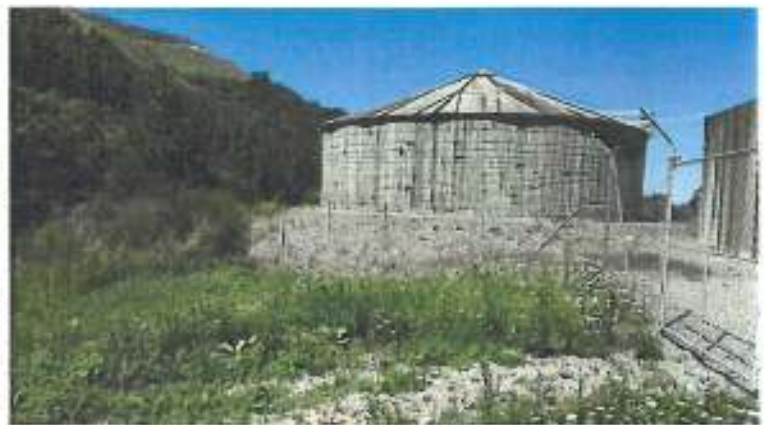
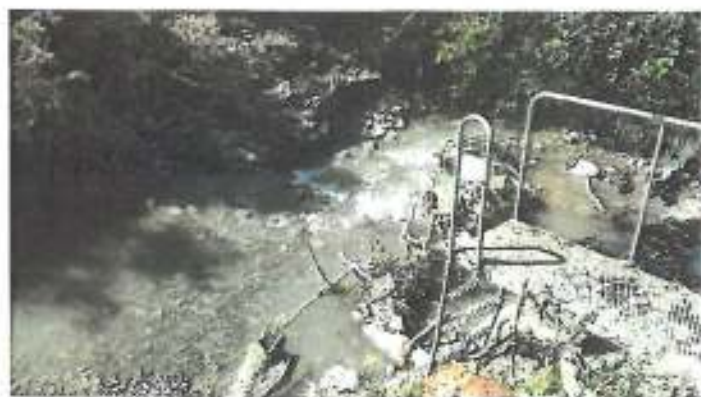
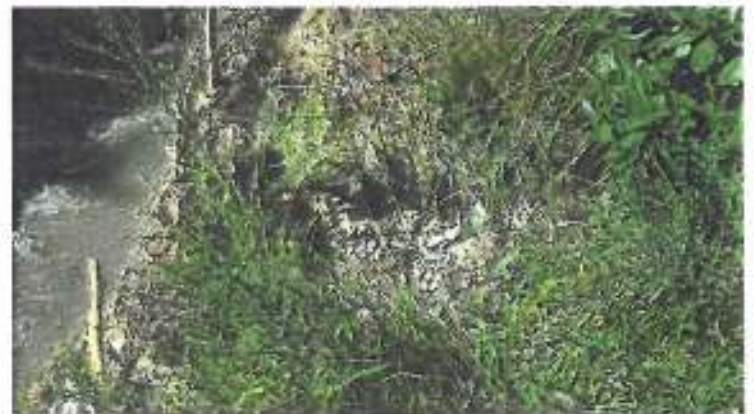
The primary damage occurred to the water intake structures. Two concrete intake structures were washed away and had to be replaced, one low weir has been replaced and the measuring weir opposite the main treatment plant has washed away. Officers will work with Greater Wellington Regional Council on a replacement of the measuring weir. Once supply is back on line the timber debris will be cleared and then the metal taken out of the dam.
