6.2 POTABLE WATER TRANSGRESSIONS

For the Committee to be informed of the actions taken following the recent potable water transgressions.

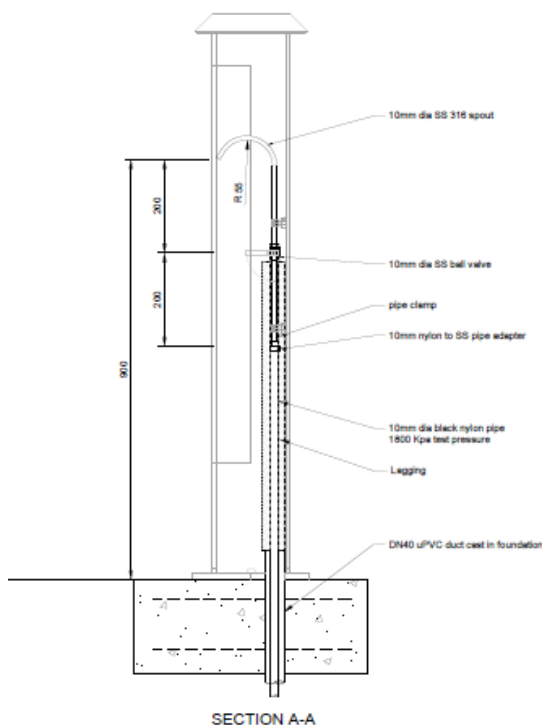
Eurofins laboratory General Manager, Rob Deacon, undertook a review of sampling techniques used by CDC staff and advised on improvements that could be made. These were immediately introduced with refresher training for all sampling staff to be undertaken the following week. It was also recommended that sampling points used were dedicated and secure. A design was offered (see Figure 1 below) and an order was placed for manufacture.

Figure 1: Schematic of dedicated and secure potable water sampling points

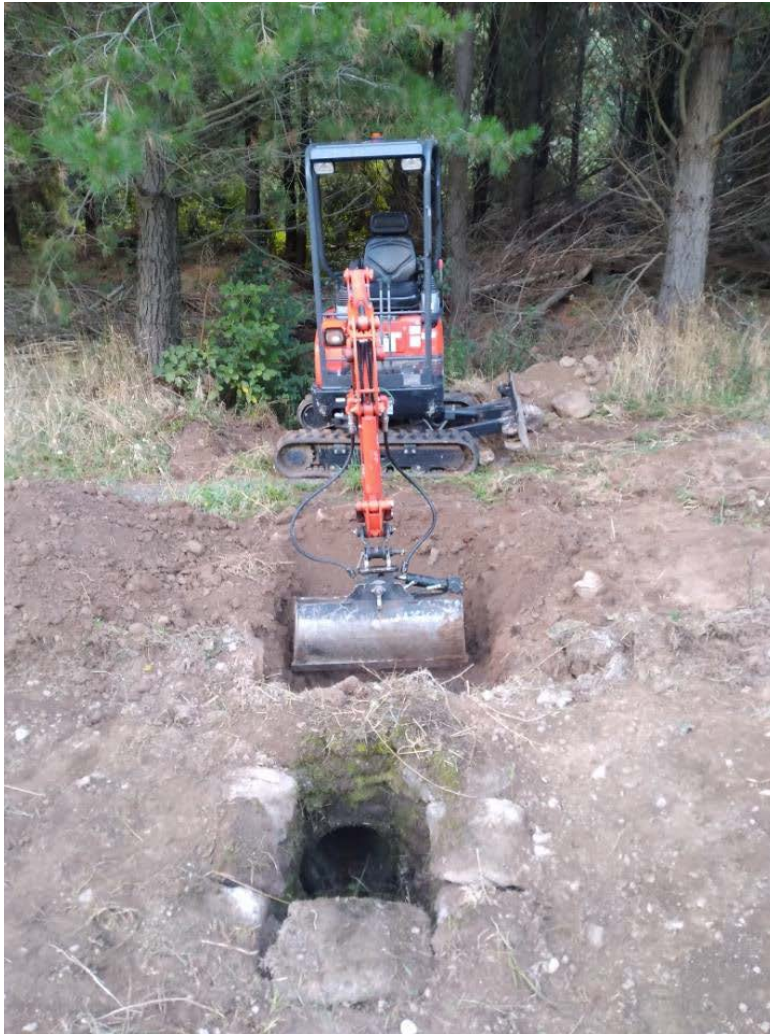
Kaipaitangata treatment plant, along the water trunk mains leading into town there is a disused scour valve. At some point in the past 2 decades a culvert that crossed under the road was installed. Also created was a sump that incorporated the scour valve outlet (Figure 2). Critically, the scour valve outlet was at a level below both the culvert inlet and outlet creating a pool in which the disused scour valve outlet sat (Figure 3). The pressure at this high end of the Kaipaitangata main trunk line is surprisingly light at approx. 20psi and with a potential of a failure of the scour valve allowing for the ponded and stagnant water to enter the main trunk line.

Figure 2: The foreground shows the culvert sump with the outlet of the culvert seen in the picture.

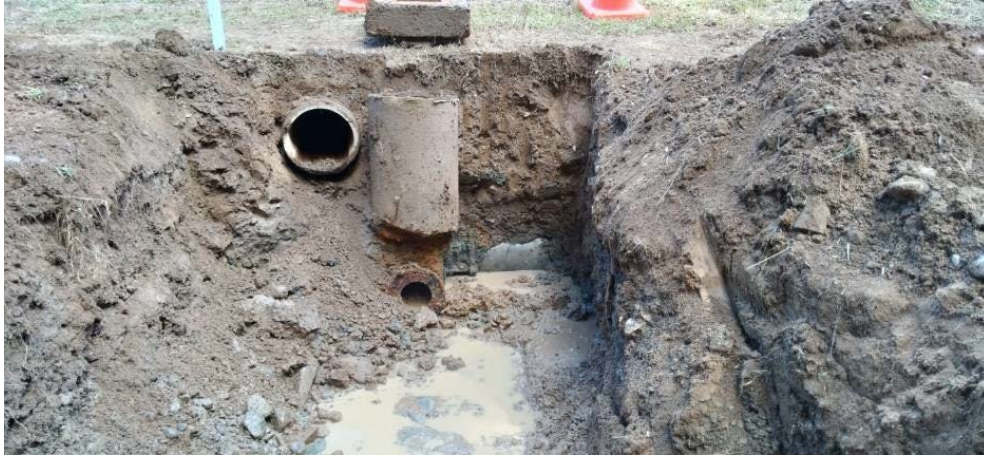
Figure 3: A view of the culvert (top left) and the scour valve visible at the base of the trench.

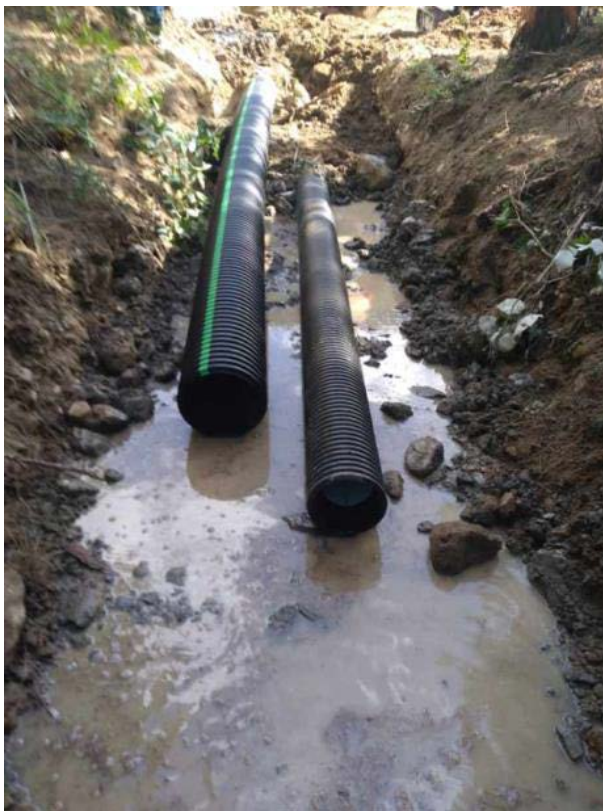
Figure 4: Pipe extension attached to both the culvert and replaced scour valve outlet.

On the morning of Friday 19th March, the sump was dug out and piping installed (Figure 4) to remove any discharge and eliminate any contamination potential with headworks being completed in the following week. Extensive reticulation flushing was undertaken commencing the afternoon of Friday 19th March and completed on Saturday 20th.
