Norfolk Road Walking and Cycling Trail

Detailed Design Stage Safe System Audit Report

Prepared for Carterton District Council

REVISION 1 - FEBRUARY 2023

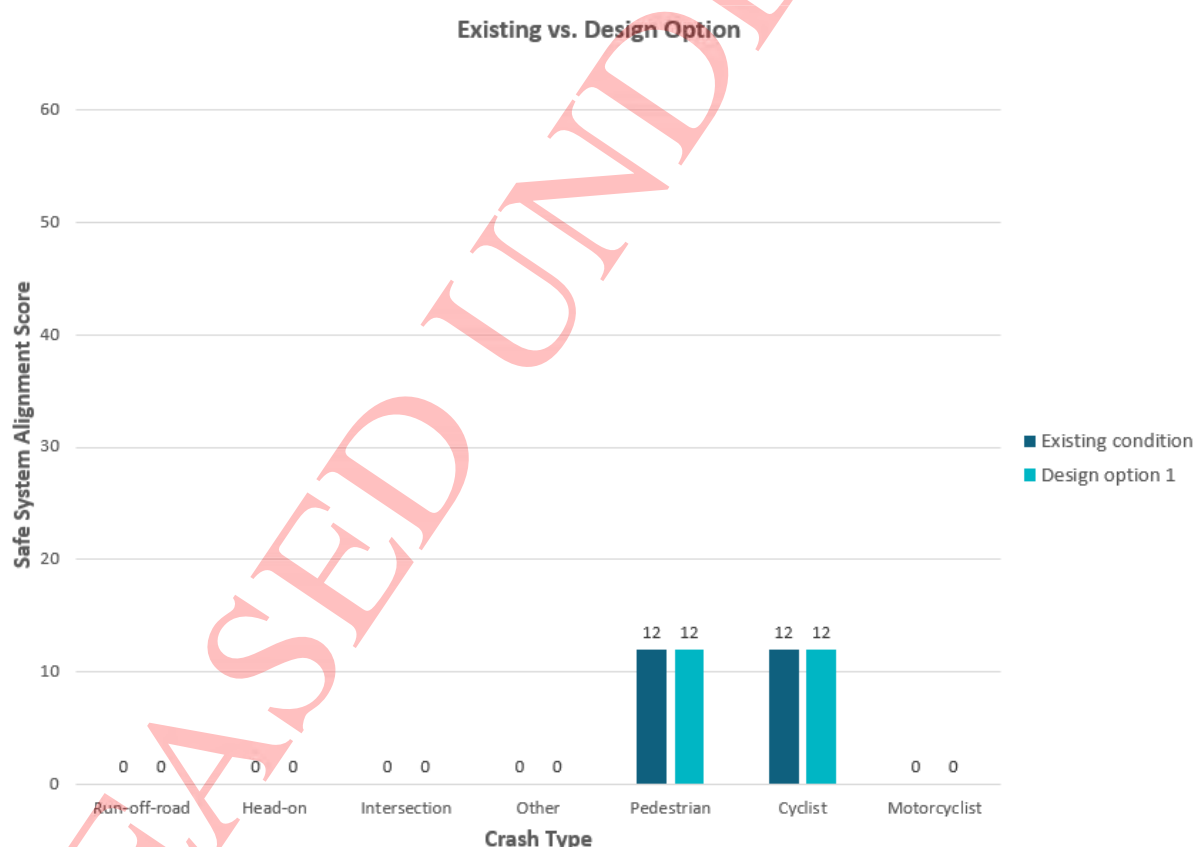
Figure 4.1-1 - Safe System Assessment Score Summary

The Safe System Assessment (SSA) shows that the scores for the existing and proposed situation are the same. However, some considerations are required to be made as the project is considered a significant improvement for these vulnerable road user's categories, as follows:

- The scores for the existing conditions are driven by a low road user exposure of fewer than 10 units per day for each pedestrian or cyclist user type. The proposal is expected to result in more pedestrians and cyclists through these roads, increasing the road user exposure to moderate (10 to 50 units per day for each user category). This results in an increase in scores for the proposed project;

- The crash probability (likelihood) for the existing situation has been assessed as 'Likely' due to primarily the lack of dedicated facilities for pedestrians and cyclists, which puts them at risk of being struck by vehicles on a relatively narrow road with no sealed shoulders and high operating speeds. This is considered substantially changed for the proposed condition, which has a probability assessed between 'Highly Unlikely' and 'Unlikely', due to the dedicated facilities predominantly separated from the road carriageway;

- The severity scores for both the existing and proposed conditions are the same (highly likely to result in a fatality or serious injury) due to the potentially high impact speeds for any crash involving these vulnerable road users that significantly exceeds Safe System speeds (20-30 km/h).

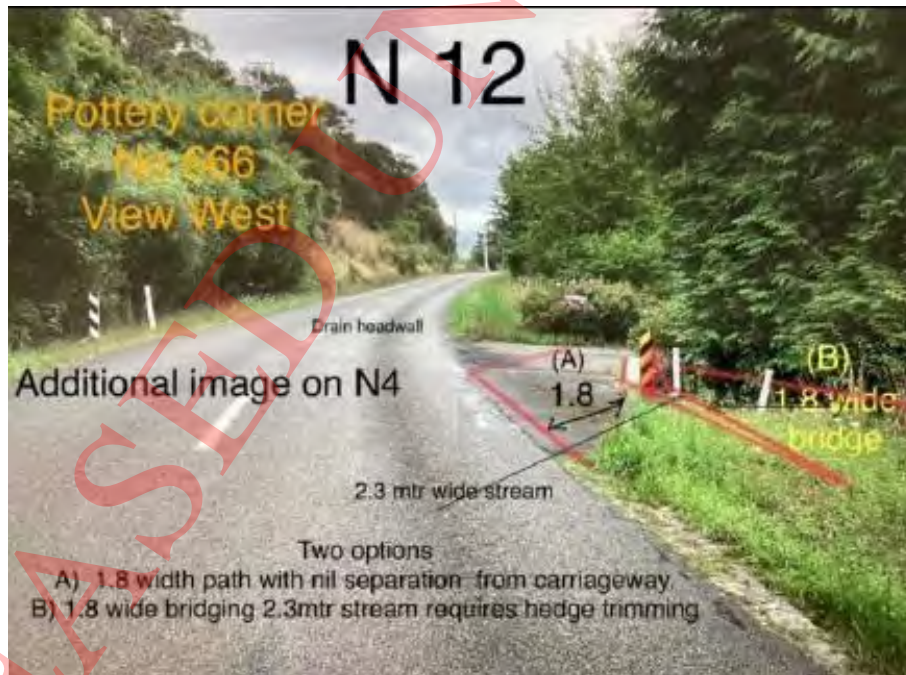
Figure 5.3-1 – Separation at 666 Norfolk Road (extract from concept design report)

- 605 – 606 Norfolk Road: 2 m separation;
- 666 Norfolk Road: nil separation (refer to Figure 5.3-1);
- 748 Norfolk Road: 0.5 m separation (refer to Figure 5.3-2);
- 889 Norfolk Road (Chester Road intersection): 1.5 m separation;
- Atiwhakatu single-lane bridge: on-road;
- Intersection corners at Maungahau Road and Parkers Road: unclear/unknown separation.

At these locations, trail users are closer to or on the road carriageway, therefore, being more susceptible to being hit by vehicles. This condition increases the probability of crashes involving these vulnerable road users at relatively high speeds, which could lead to a DSI. Note that the probability of crashes is still very unlikely at those points due to their typically short nature and low to moderate traffic and vulnerable road users volumes on these roads.

1. Provide kerb separators with safe-hit posts wherever the path is less or equal to 1.5 m from the road carriageway (example below);

2. Reduce the path width for short distances to accommodate the kerb separators with safe-hit posts if required (i.e., 666 Norfolk Road);
3. Consider boundary relocation to allow a uniform separation through the route;
4. Consider extending the existing culvert to accommodate the path at 666 Norfolk Road;
5. Provide warning signage (highlighting the presence of cyclists and/or pedestrians) at all pinch points, including the Atiwhakatu single-lane bridge.

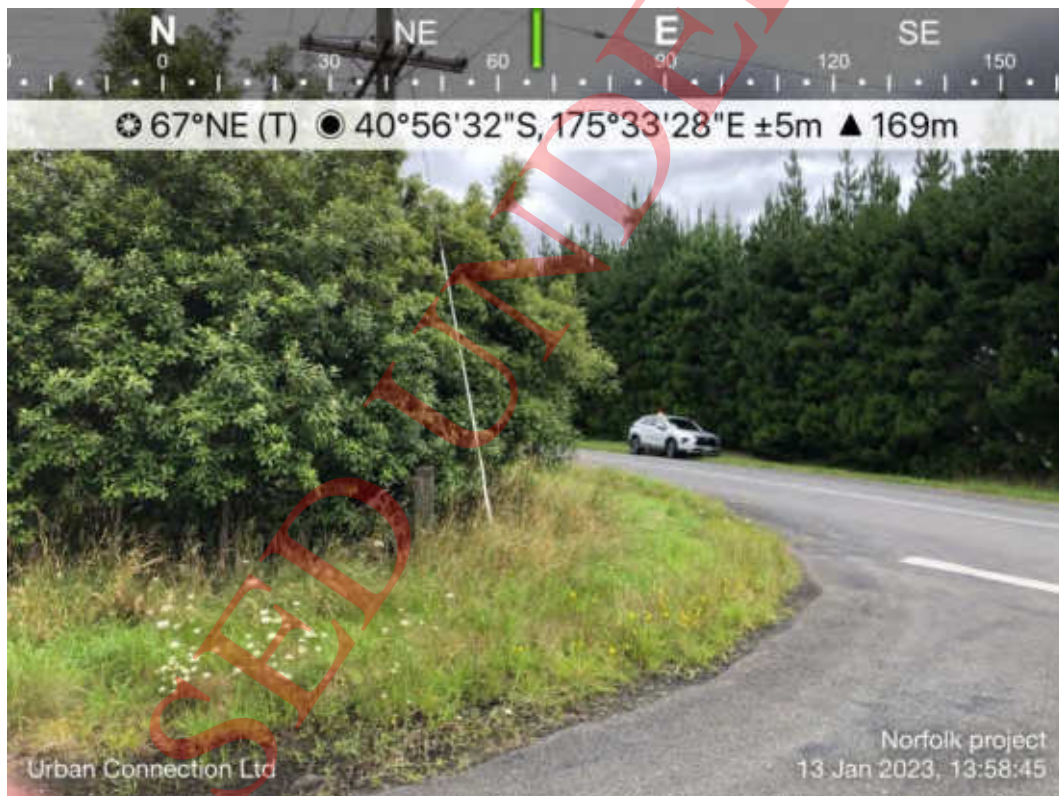
Figure 5.3-3 – Visibility from 9 m from the limit line at the Chester Road/Parkers Road intersection

Currently, the Norfolk Road/Maungahau Road intersection is give-way controlled. Chester Road/Parkers Road intersection has no control. A limit line is marked at the latter, but no signs or other markings are provided. These intersections have been found to have incorrect control in place.

As per the existing conditions, both intersections are required to be stop-controlled, given that appropriate visibility is not achieved from a point 9 m from the limit line (refer to MOTSAM Section 3.10.01).

This condition increases the probability of crashes (typically side-impact) at these intersections. The probability is still considered unlikely due to relatively low traffic volumes on these roads. However, any crash would likely result in a DSI.

Furthermore, in this condition, where vegetation blocks visibility in the vicinity of the intersections, the intervisibility between pedestrians/cyclists and vehicles is, likewise, restricted. This increases the probability of issues involving these road users.

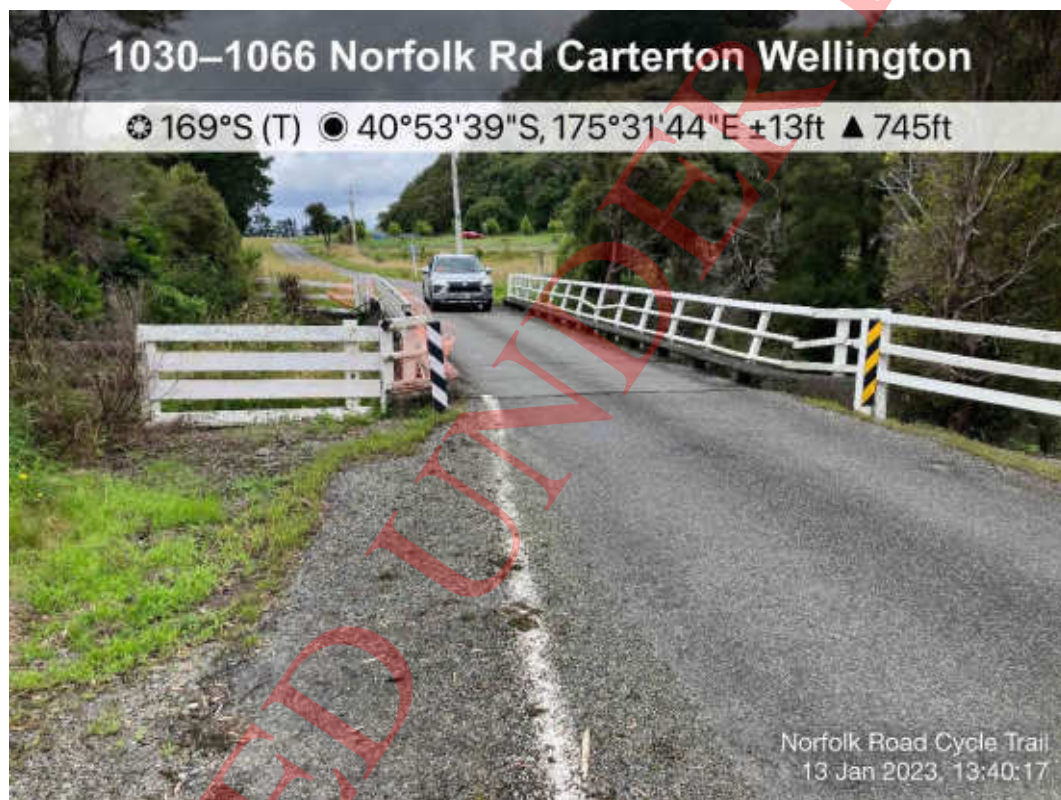
Figure 5.3-4 – Atiwhakatu Bridge

Trail users will be required to travel through the Atiwhakatu single-lane bridge, changing from an off-road to an on-road path configuration over the approximately 23 m long bridge. This condition puts vulnerable road users at risk of being struck by vehicles at this point.

The risk of this issue occurring is very unlikely due to relatively low traffic volumes and good forward visibility from both directions. However, considering the high operating speed on Norfolk Road, any crash involving pedestrians/cyclists would likely result in a DSI.

Furthermore, the bridge's side barriers are broken in some sections and present deterioration signs. Due to increased pedestrians/cyclist's volumes, this device is important in protecting against the drop-off into the water hazard.

1. Provide warning signage on the bridge's approaches (i.e., cyclists merging, beware of cyclists);
2. Consider an ITS solution, such as an electronic warning sign (traditional signage may lose its effect quickly)
3. Repair the bridge's barriers;

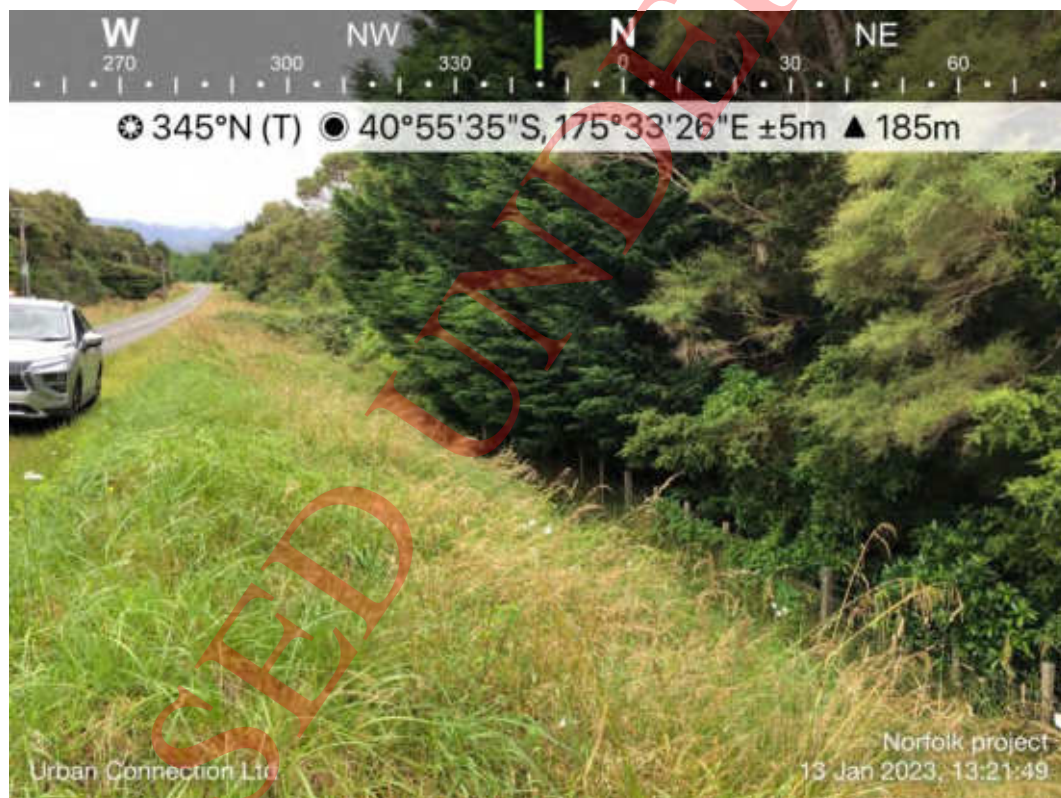
Figure 5.3-5 – Drop-off at Norfolk Road RP 6.150

- Drop-off hazard on Norfolk Road from approximately RP 6.045 to 6.300 (refer to Figure 5.3-5);
- Drop-off into the water hazards on culverts/water races at 570, 666, 855 Norfolk Road and 792 Chester Road (refer to Figure 5.3-6);
- Overhung vegetation for a significant portion of these roads (refer to Figure 5.3-7);
- Letterboxes throughout these roads that are within or immediately adjacent to the proposed path (refer to Figure 5.3-8). Particular regard has to be taken in relation to non-frangible and/or rigid letterboxes, for instance, as identified at 315 Norfolk Road (refer to Figure 5.3-9). These structures are a hazard not only for cyclists but for vehicles, increasing the severity of injuries in the case of an errant manoeuvre.

1. *Identify all locations/objects that present a hazard for trail users;*
2. *Provide cycle fence/rails to protect against the hazards;*
3. *Relocate letterboxes to suitable locations;*
4. *Remove and relocate rigid letterboxes, switching them to frangible-type letterboxes.*

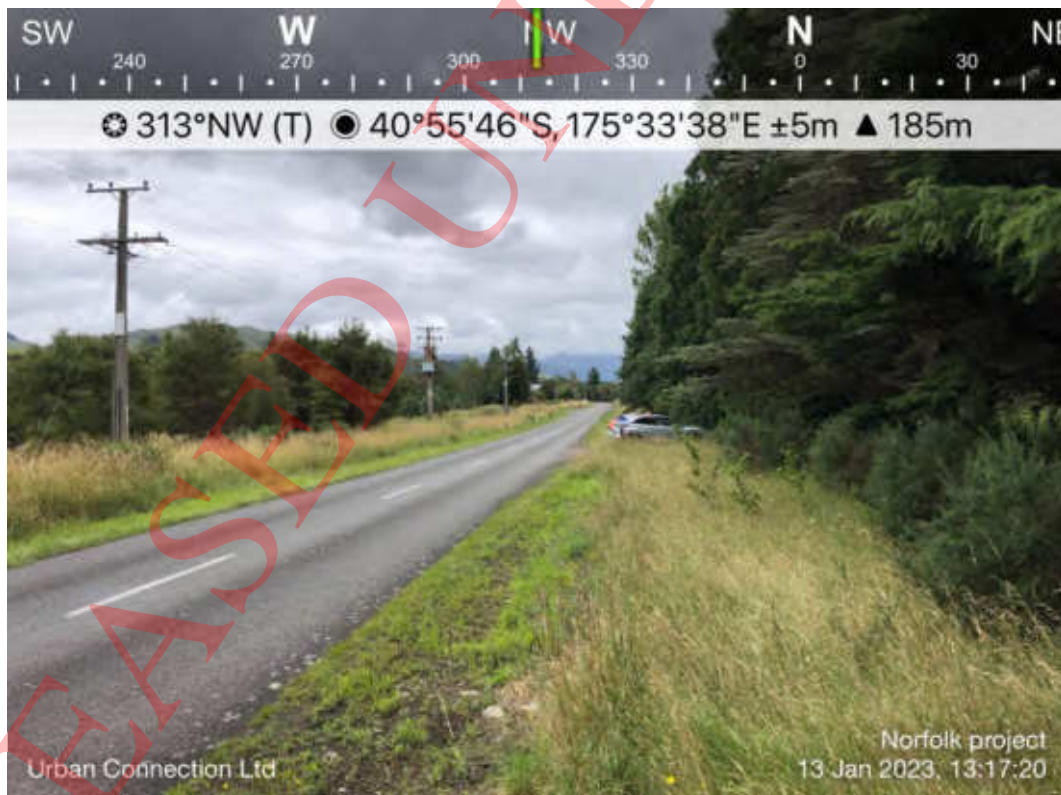
Figure 5.3-7 – Overhung vegetation

Some locations through the proposed project alignment have been identified to present hazards that can potentially injure trail users. These hazards are listed below:

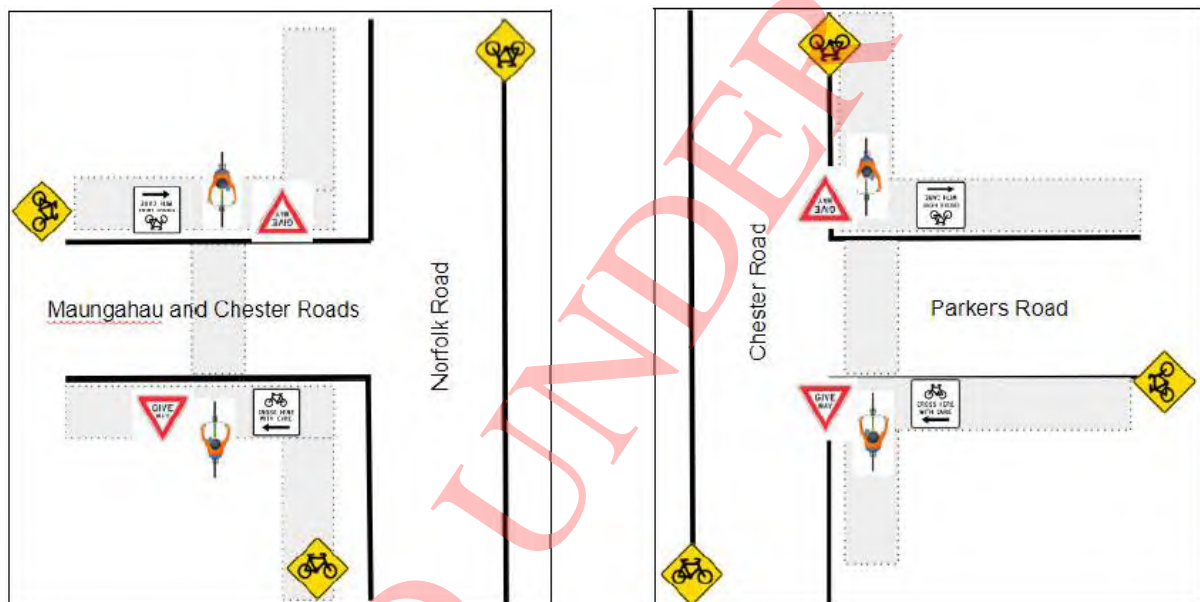
Figure 5.3-10 – Treatment at intersections

A horizontal deflection is proposed from Norfolk Road onto both Maungahau and Chester Roads, with the path crossing somewhat 20-30 m from the intersections. A straight crossing path is proposed through Parkers Road. The proposed layouts are shown in Figure 5.3-10.

- The crossings on Maungahau and Chester Roads (20-30 m from Norfolk Road) result in restricted intervisibility between cyclists/pedestrians and vehicles turning from Norfolk Road. It is noted, however, that these vehicles would be expected to generally be turning out from Norfolk Road with relatively low speeds, which provides some form of mitigation;

- In the vicinity of the intersections, the trail could also be expected to have less separation from the carriageway, increasing the chances for errant turning vehicles encroaching over the path. It could also mean that errant cyclists could encroach onto the road while turning, especially in wet conditions. These conditions increase the probability of conflicts involving these users;

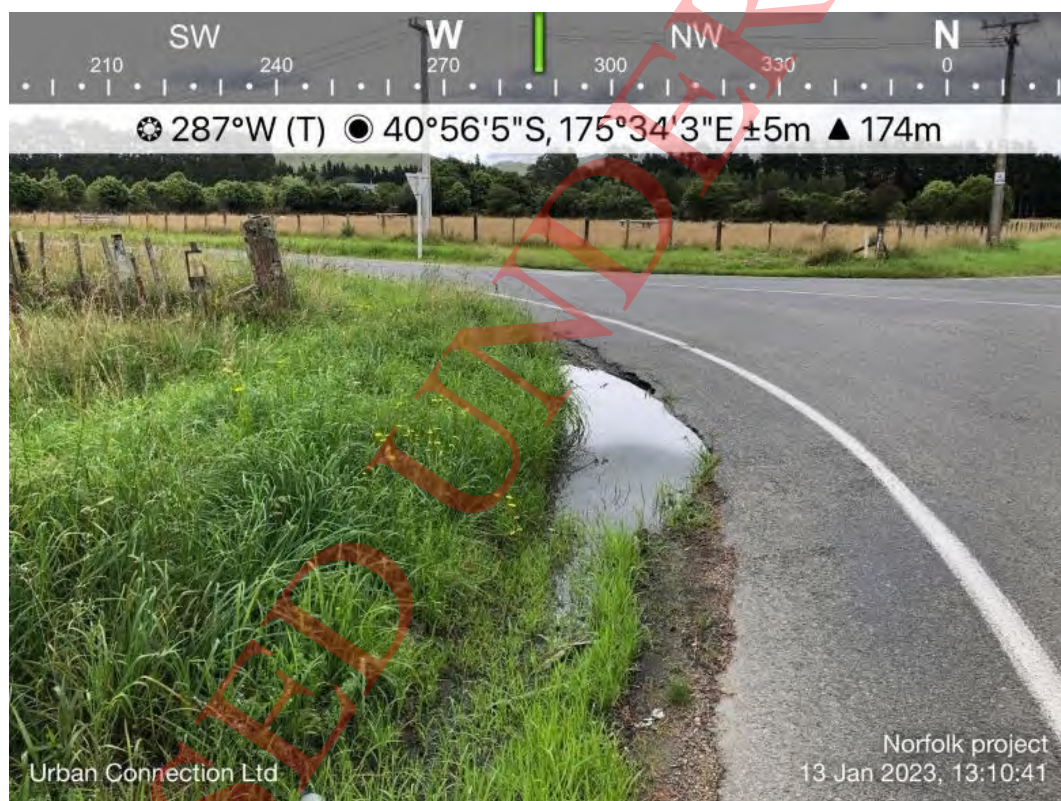
Figure 5.3-11 – Stormwater runoff at the Norfolk Road/Chester Road intersection

At the Norfolk Road/Chester Road intersection, stormwater runoff was accumulated at the intersection's corner during the site visit. Therefore, it is assessed that stormwater is not being appropriately directed and conveyed into the drainage system. The following safety issues have been identified as a result:

- Cyclists could be expected to have their stability adversely affected by this issue, which could lead to them falling off their bikes. This risk is increased by the trail's horizontal deflection at this point;
- Stormwater runoff could be expected to migrate onto the pavement during moderate to intense rainfall events. This could adversely affect the stability of turning vehicles due to aquaplaning;
- Deficient drainage can lead to pavement defects (i.e., such as edge breaks and potholes). Deficient drainage at this point could also lead to the deterioration of the proposed trail.

1. *Ensure that this drainage deficiency is repaired.*

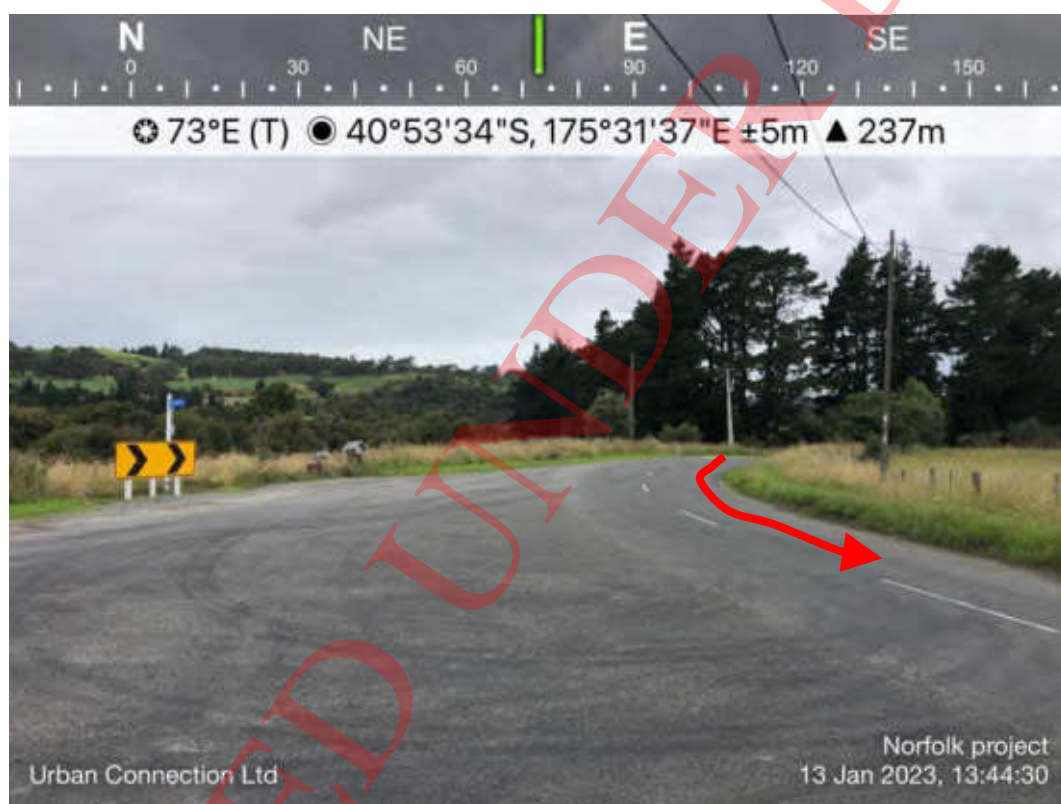
Figure 5.3-12 – Norfolk Road/Mt Holdsworth intersection forward visibility

The forward visibility at the Norfolk Road/Mt Holdsworth Road/Blakes Road intersection has been assessed as deficient. Assuming a vehicle waiting to turn right onto Blakes Road, the following vehicle could hit this vehicle from behind (rear-end crash) due to the above deficiency (red arrow below). Some increase in right-turn volumes, although relatively minor, can be expected to occur at this intersection due to the parking area proposed on Blakes Road, which could indicate some increase in risk.

However, it is noted that the turning volumes at this intersection are still considered relatively low. This establishes an unlikely probability of crashes. Moreover, the relatively low turning speeds due to the horizontal curve and low impact angles suggest a low DSI crash risk.
