LOCAL GOVERNMENT OFFICIAL INFORMATION AND MEETINGS ACT Request: 2023-71

SOURCE WATER MANAGEMENT PLAN

REVIEWED 2022

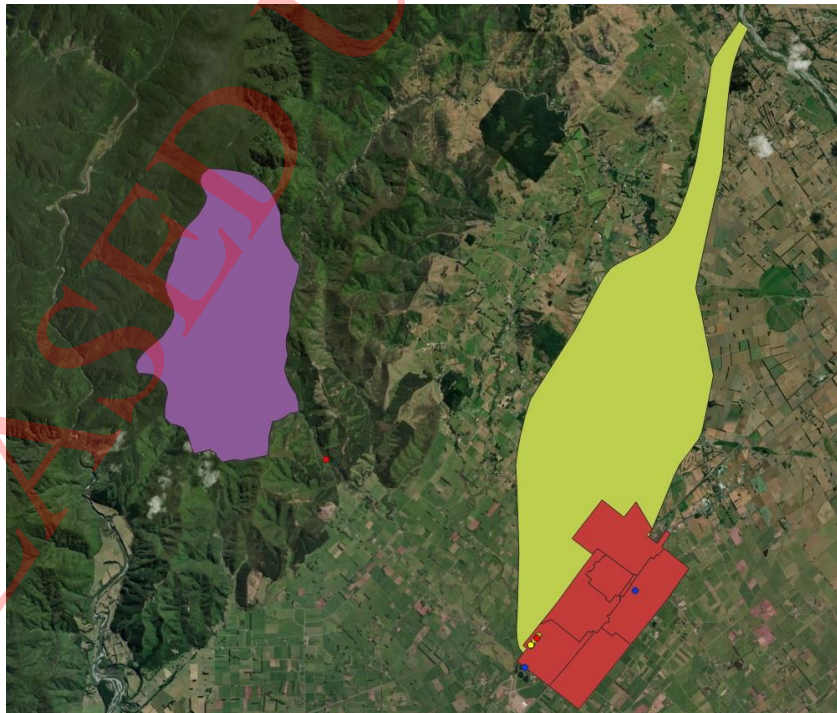
The Carterton drinking-water supply abstracts water primarily from three bores located next to Lincoln Street, Carterton. The water is pumped to Frederick St plant where it is UV disinfected pH adjusted and chlorinated before storage. The stored water is then pumped into the Carterton network. The other source, with water supplied from the Kaipatangata Water Treatment Plant. The Kaipatangata plant abstracts water from the Kaipatangata stream via a couple of concrete chambers within the stream. The Kaipatangata plant filters water through a 2 stage process, sand filters then bag filter, before UV disinfection, chlorination and pH correction and stores the water in two reservoirs on-site. This water can be delivered under gravity to the Carterton network.

Figure 1: Overview of Carterton water sources

The catchment for the Kaipatangata upstream of the intake chambers is approximately 600 hectares. The topographic maps (Figure 1, Figure 2) provides an outline of the catchment area. It has been determined using GIS analysis to include the small tributaries with potential to contribute water to the point of abstraction for the Kaipatangata drinking-water supply.

The catchment for the Frederick St bores extends over a large distance. The topographic maps (Figure 1, Figure 3) provides an outline of the catchment area. This area has been taken from the zone protection area modelled by Wellington Regional Council (WRC) as part of proposed natural resources plan. The calibrated model capture zones highlights the area where influences from the surface may flow through to the bore abstraction points over a 10 year period. Figure 4 shows the different time periods; 1, 2, 5, and 10 year that were evaluated.

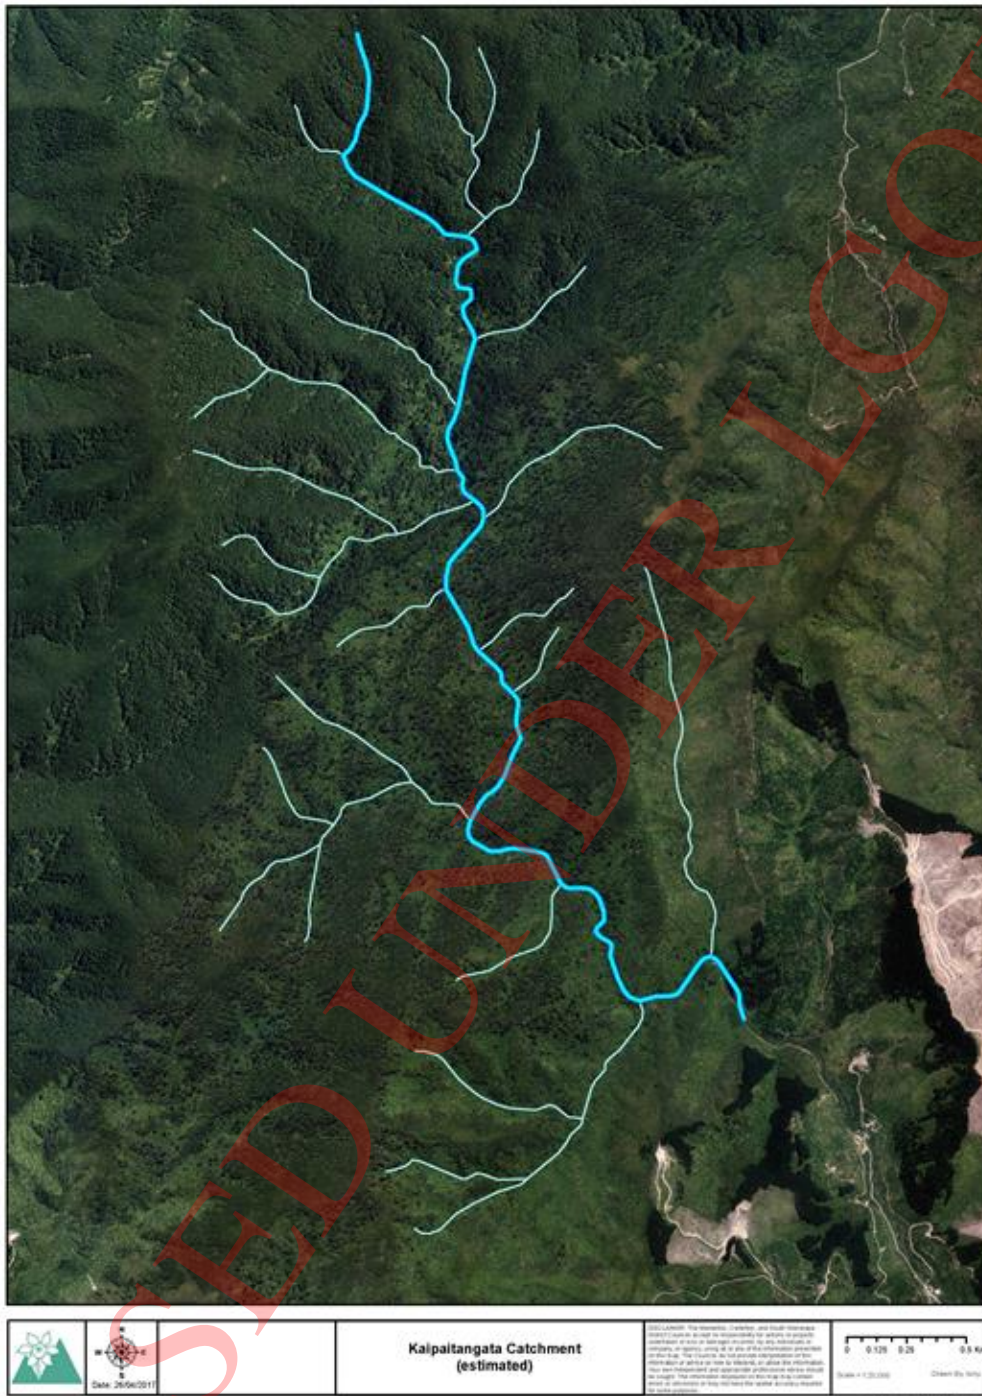
The land use map below (Figure 2) identifies the area of the catchment and the land use of that area. The vast majority of the catchment is within the Tararua State Forest Park and is covered with indigenous forest and some pine forestry.

Figure 2: Kaipatangata stream catchment

There is likely to be feral animals in the forested areas of the catchment such as possums, rodents, wild pigs and deer. There are likely to be few human activities in the catchment aside from recreational activities, such as, tramping, cycling and hunting. The water course is small and does not enable any in stream activities.

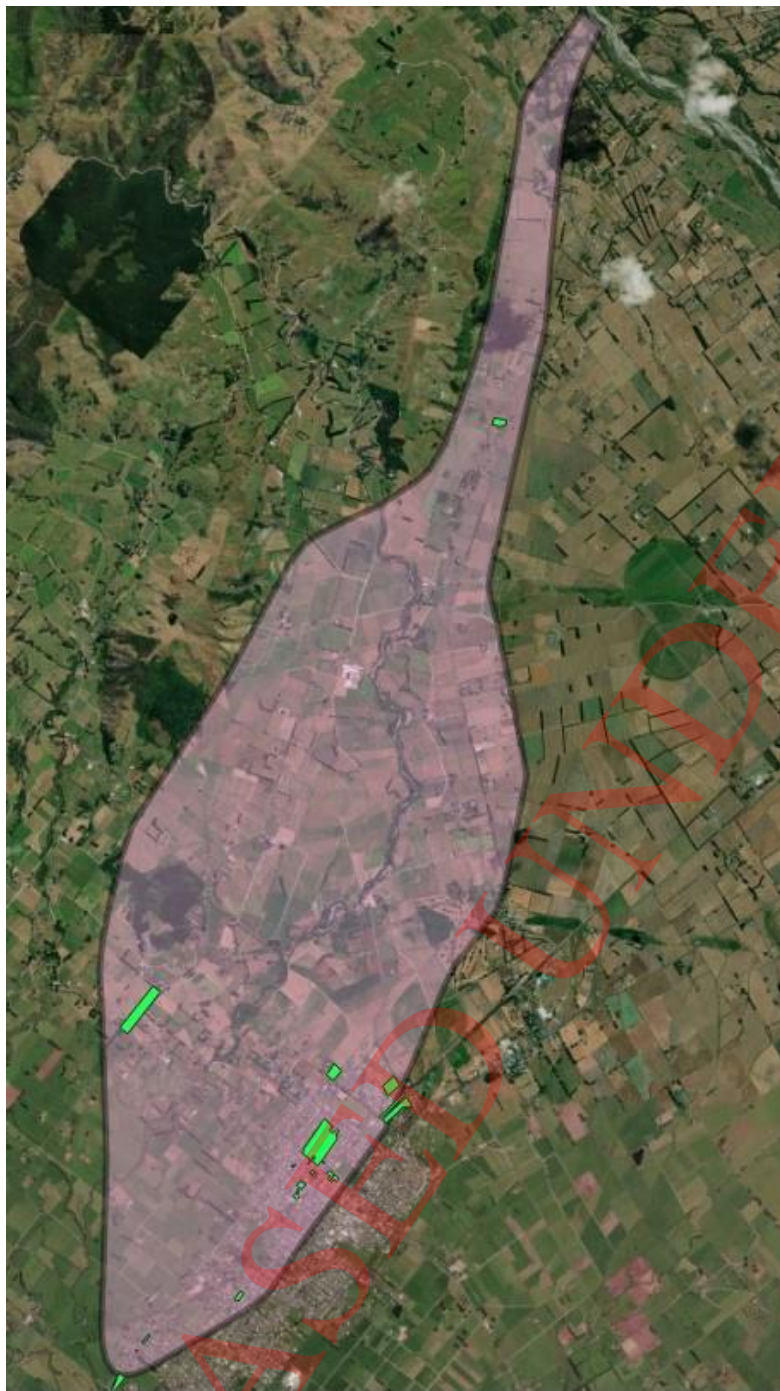
Figure 5 Site with land use risks – SLUR register map
