CONTAMINATION – PSI

3954A State Highway 2

Preliminary Site Investigation

for: NZ Clean Energy Limited

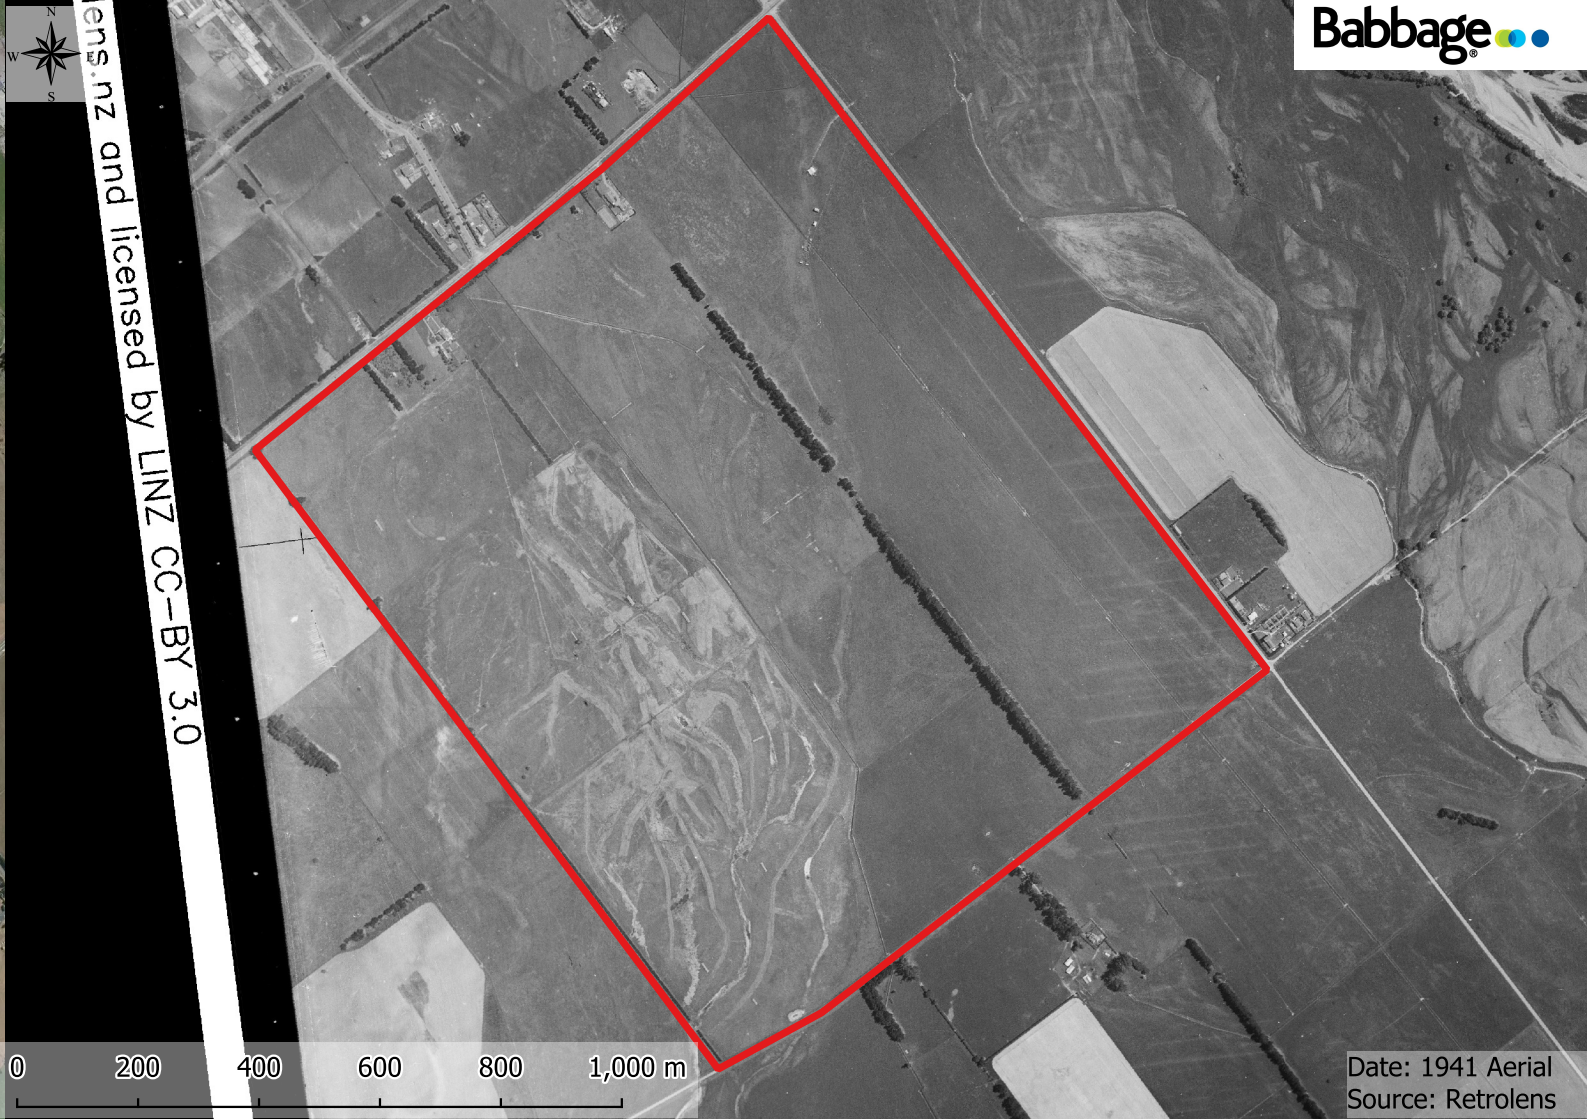
Date: 1941 Aerial
Source: Retrolens

Year	Site	Surrounding land use
1941	Majority of the site appears vacant apart from two dwellings visible towards the north-western portion of the site. A tree line can be seen separating part of the site. A few tracks are visible to the west of the site. Some activity is observed in southwest portion of the site (structures scattered and what appears to be discharges to land or tracks)	The site is surrounded by mostly pastoral land. State Highway 2 and a few residential properties are visible to the north. Wiangawa River can be seen further east of the site. Some commercial/industrial activity is observed north of the residential properties and southeast.
1969	The western portion of the site appears to be in the process of being used as part of fellmongery operations with what appears to be ponds and potential chemical treatment processes observed towards the central portion of the site. A patch of land towards the eastern site boundary appears to be fallow.	Surrounding site is still predominantly pastoral with further residential properties developed to the north of the site.

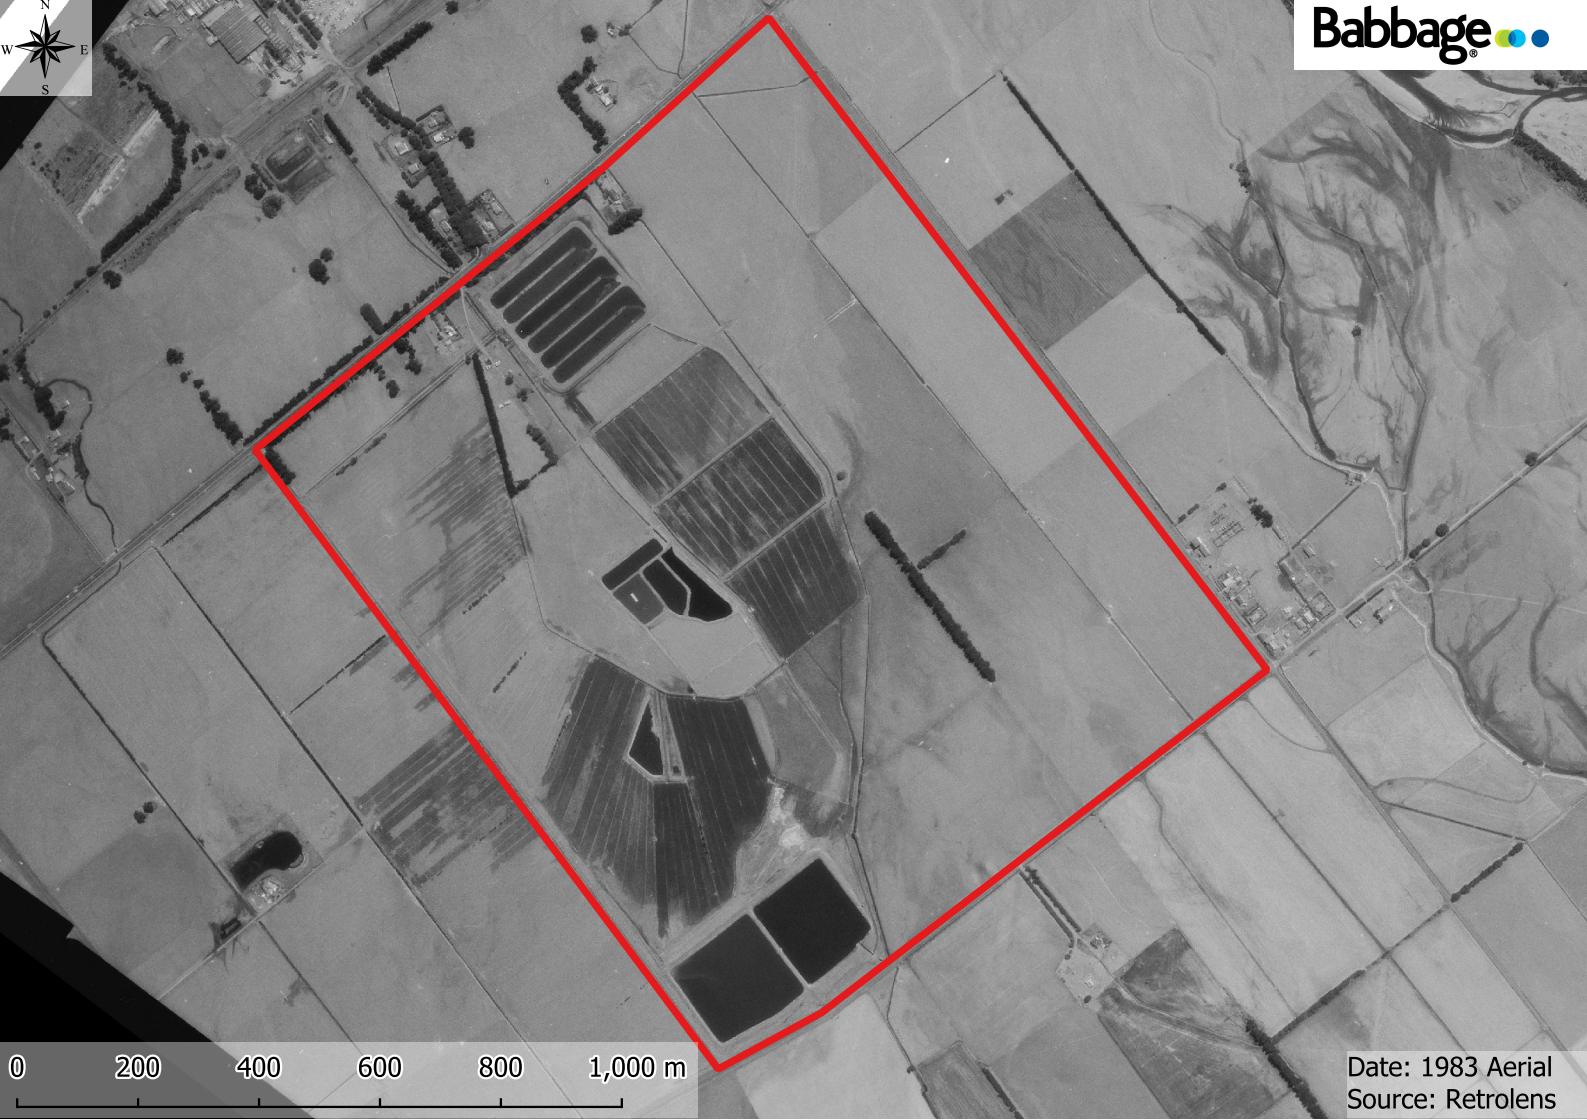
Date: 1983 Aerial
Source: Retrolens

1983	The eastern portion of the site now appears to be completely used as part of fellmongery operations. Specific areas potentially used for many stages of the processing, i.e. for washing chemicals and other processes are now visible on site. A few new structures can be seen formed immediately south of the existing dwellings occupying the north-western site corner. A tree shelter belt can also be seen surrounding these structures.	No significant changes apparent in surrounding area.
2003	Fellmongery operations appear to have ceased across majority of the western portion of the site with ponds decommissioned and filled in,	No significant changes apparent in surrounding area.

<p>some remnants of site operations can be seen to the northern site corner, immediately adjacent to existing dwellings.</p> <p>A patch of trees can be seen formed towards the south-western site corner. The remainder of the site appears vacant and in pastoral land use.</p>	
2008-2013	<p>Majority of the western portion of the site appears vacant with a few structures visible to the north-west.</p> <p>The eastern portion of the site appears to be used for horticultural purposes.</p>	Commercial development to the north increasing.
2018-2021	<p>Horticultural activity appears to have ceased across the site. Site appears to be in pastoral use.</p>	Commercial development to the north increasing.
