January 2022

Carterton District Council-

Playground Report 2022

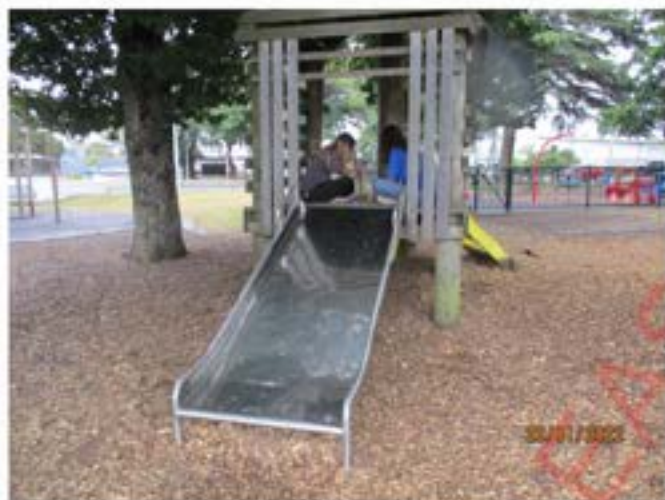
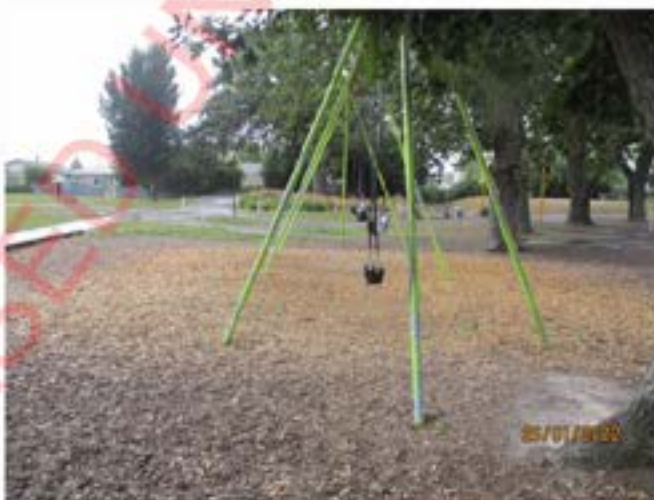
Carrington Park Playspace clearly receives a high level of use. It appears tired and in poor condition.

A number of the new synthetic safety surfaces were performing poorly, in particular the tiles and wetpour. These should be followed up with the supplier and the warranty reviewed- they are likely past their warranty period. The Council should be getting better lifespan out of the synthetic surfaces.

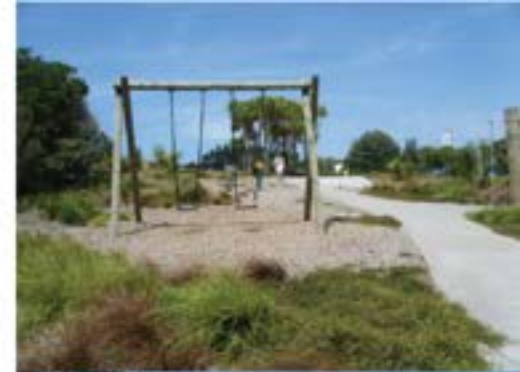
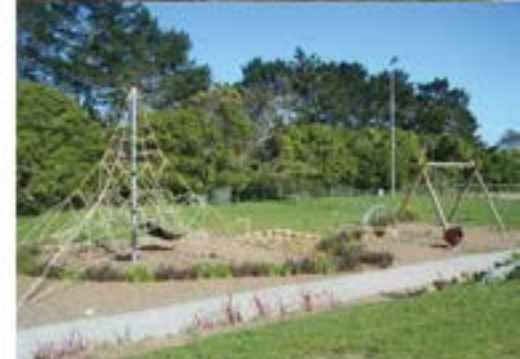
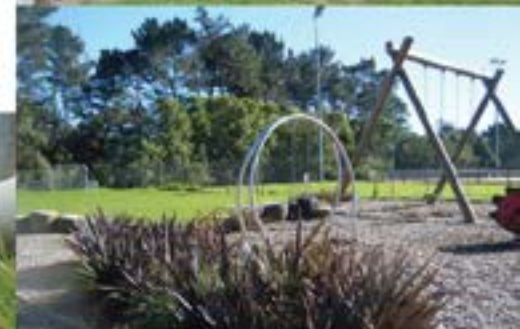
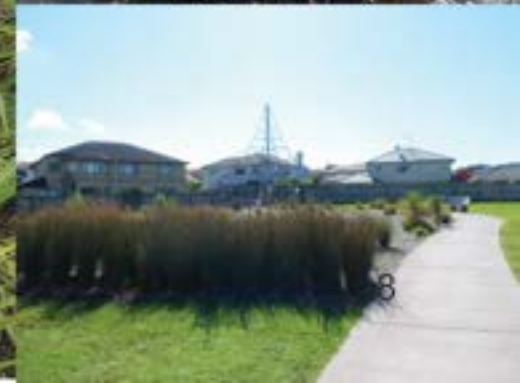
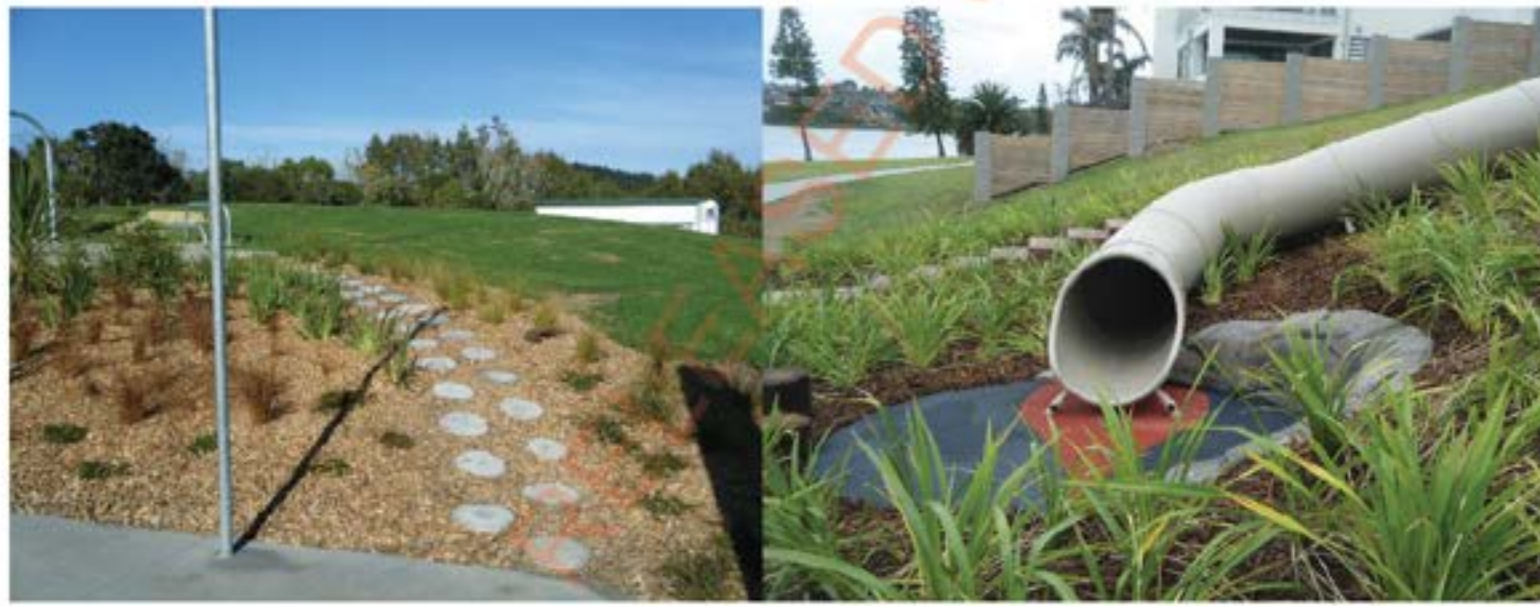
The use of the cushionfall in place of bark is improving the use and maintenance of the playground surfacing. Planting within these surfaces would also assist the retention of the loosefill, and can provide retaining of the loosefill, provides improved aesthetics and a measure of play value.

Photo images are examples of planting in the loosefill surface.
