#### LOCAL GOVERNMENT OFFICIAL INFORMATION AND MEETINGS ACT Request: 2023-42

#### CDC PLAYGROUND REVIEW STRUCTURAL ASSESSMENT AND STRENGTHENING

## PLAYSAFE AUDIT REPORT 2023

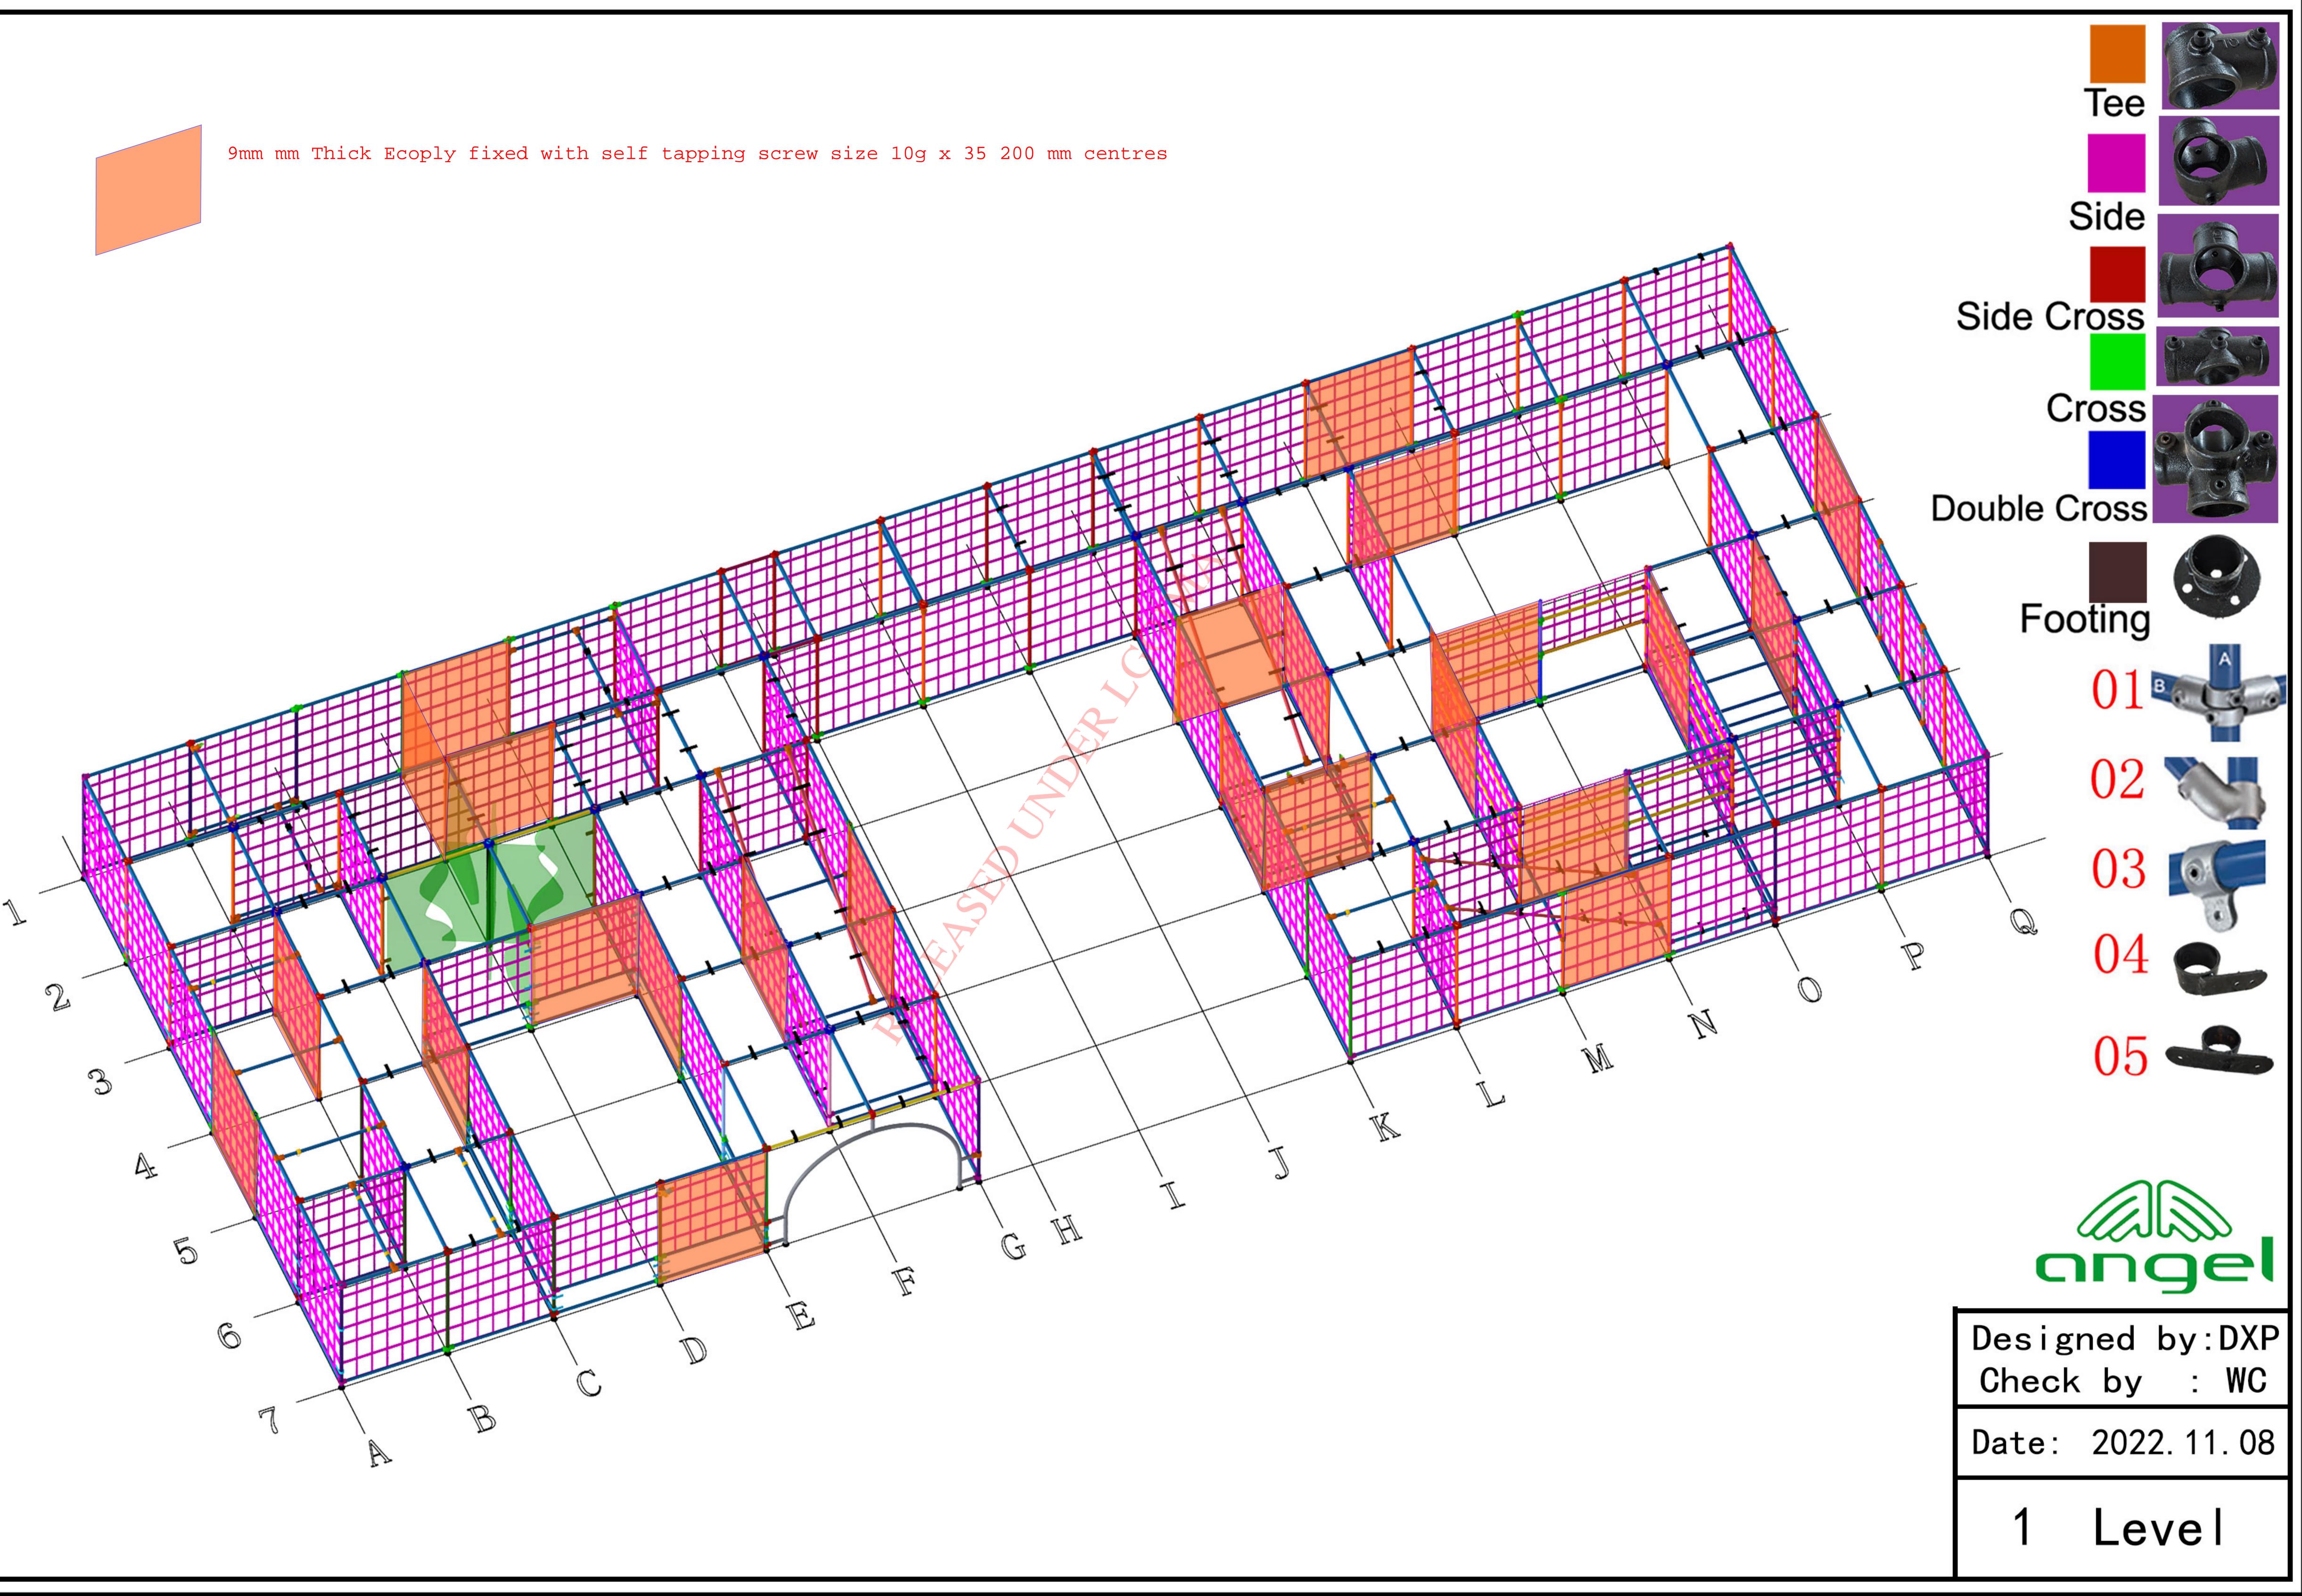
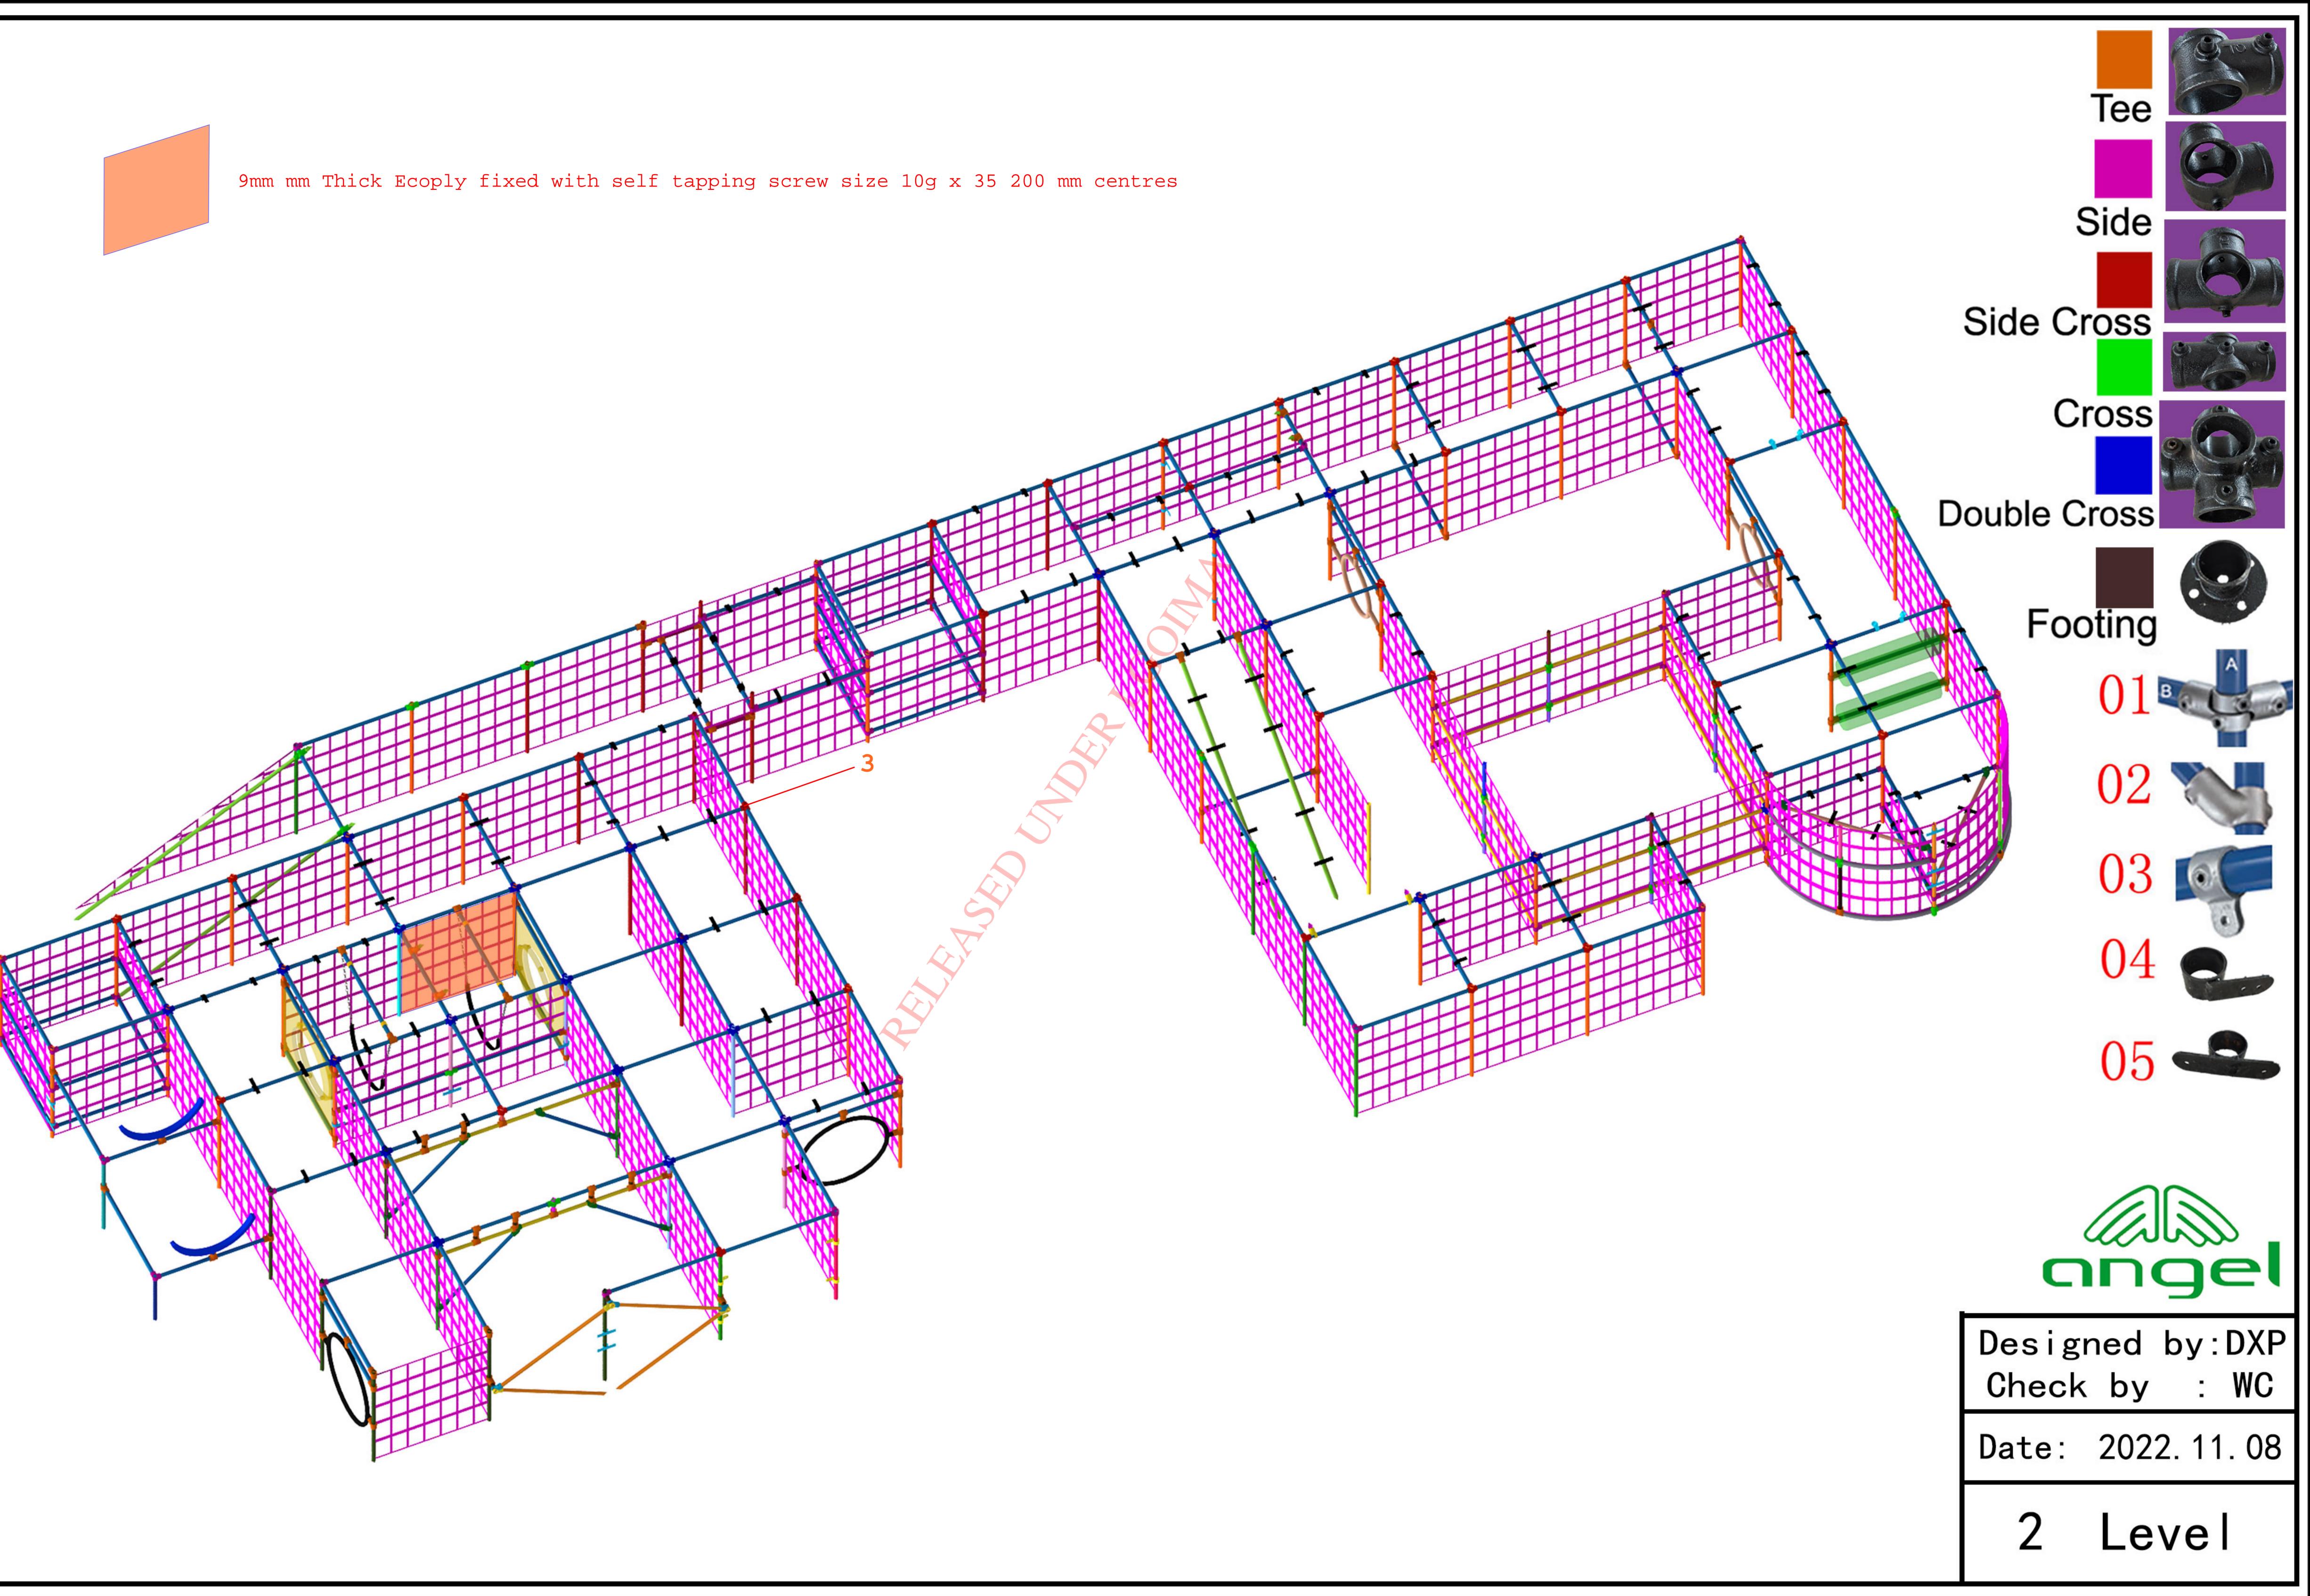
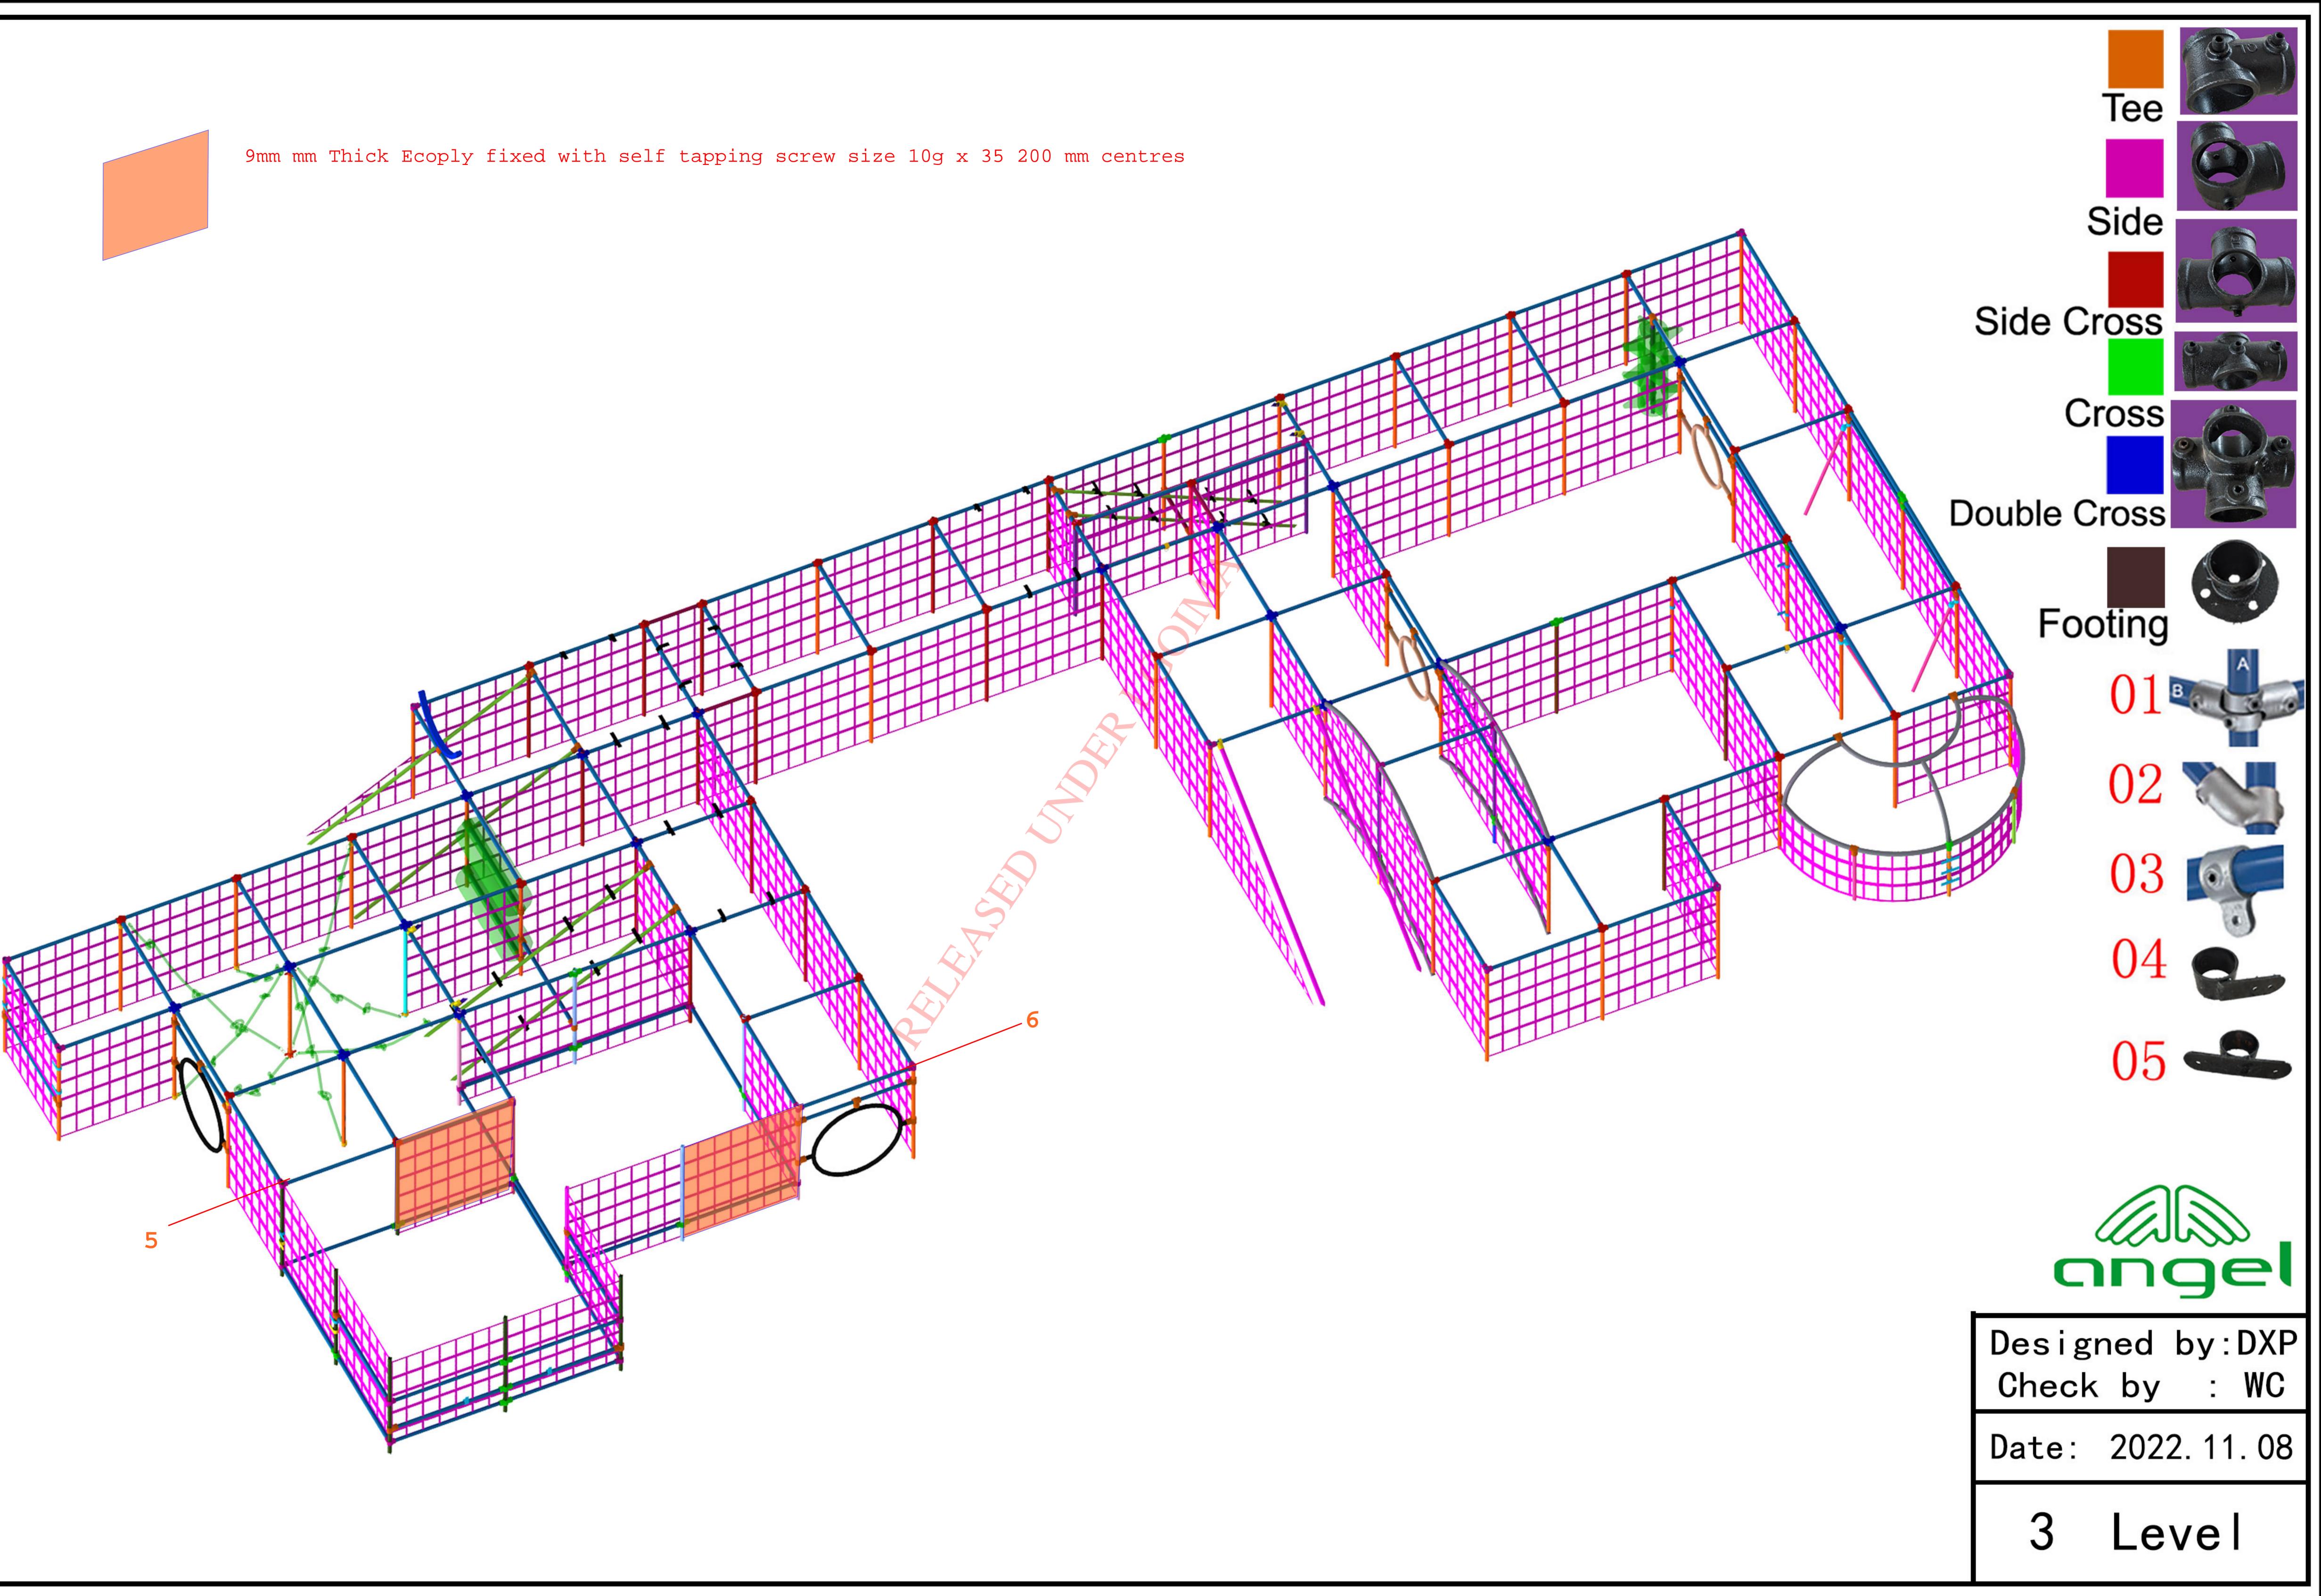
EQUIPMENT	COMMENTS	RECOMMENDATIONS
Large Playground	• The overall structure does not satisfy the lateral load criteria as per NZS 5828:2015.	<ul> <li>Add 9mm plywood in both transverse and longitudinal direction as shown in the attached sketch to satisfy the lateral load requirements</li> </ul>
Donut Slide	<ul> <li>The SHS columns and beams are able to resist the user loads as per NZS5828:2015.</li> <li>The 16mm thick plywood will resist lateral capacity as per NZS5828:2015 and NZS1170.5:2004.</li> </ul>	• No rectification required
Trampoline	<ul> <li>The trampoline structures are not sufficient for the user loading as per NZS5828:2015.</li> <li>The existing structural arrangement are not designed to resist lateral loadings as per NZS5828:2015.</li> </ul>	<ul> <li>Add 9mm plywood in both transverse and longitudinal direction as shown in the attached sketch to satisfy the lateral and vertical load requirements</li> </ul>

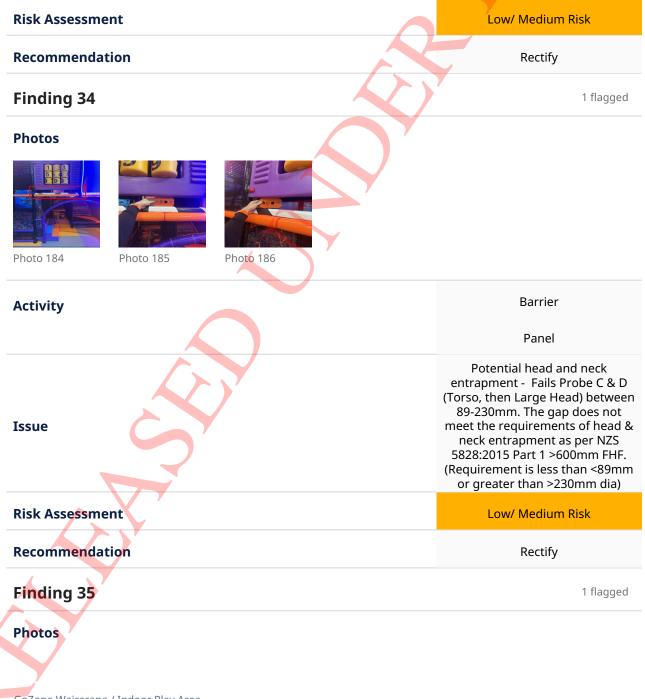
Potential head and neck wedge entrapment. The V gap does not meet the requirements of neck wedge entrapment as per NZS 5828:2015 Part 1. A partially bound opening is any opening which has at least one side or portion open and could leave a user trapped and suspended by the neck. (Gap should be less than <45mm wide/deep to not consider the wedge probe)

Th gaps above the fixed panels and the revolving panels are a A/B probe non-compliance. They are a position 2 wedge as per EN 1176 and ideally the gaps between the top of these panels and structure above should be less than 45mm or over 230mm

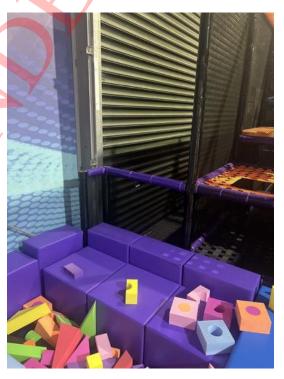
Photo 74

Activity	Barrier
Issue	Barrier - The height to the top of the barrier shall be at least 700 mm measured from the surface of the platform, stairs or ramp.
	Climbing is reasonably foreseeable on this item especially if movable resources are placed next to it.
	Relocate/ reconfigure the movable equipment to achieve min fall zone / falling space requirements.
Risk Assessment	Low/ Medium Risk
Recommendation	Rectify
Finding 6	
Photos	
Photo 78 Photo 79	
Activity	Panel
Issue	Missing fastenings - Replace.
Risk Assessment	Low Risk
Recommendation	Refasten
Finding 7	1 flagged
Photos	
, J

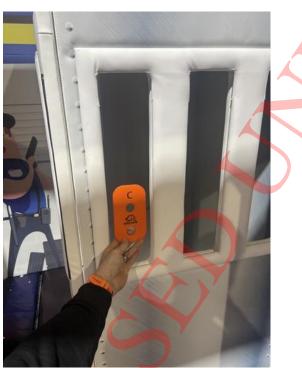
# Activity Fire house Excessive movement / racking on this item. Recommend further Issue bracing. Given the narrow, tall shape / This should be wall or floor mounted Low/ Medium Risk **Risk Assessment** Refasten Recommendation Reposition / Move 1 flagged **Finding 9 Photos** Photo 89 Photo 90 Photo 91 Photo 92 Photo 94 Photo 93 Activity Police station Potential head and neck entrapment - Fails Probe C & D (Torso, then Large Head) between 89-230mm. The gap does not meet the requirements of head & Issue neck entrapment as per NZS 5828:2015 Part 1 >600mm FHF. (Requirement is less than <89mm or greater than >230mm dia) **Risk Assessment** Low/ Medium Risk **Recommendation** Rectify Finding 10 1 flagged Photos -4

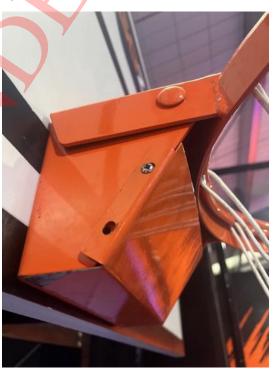
# **Risk Assessment** Recommendation Rectify Finding 21 1 flagged **Photos** Photo 136 Photo 134 Photo 135 Activity Ноор All exposed bolt threads should Issue be cut off and bolt heads / nuts

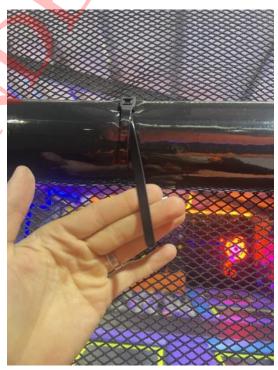
Risk Assessment	High Risk (Close ASAP)
Recommendation	Rectify
Finding 25	
Photos	
Photo 147 Photo 148	
Activity	Trampoline
	Fence Panel
GoZone Wairarapa / Indoor Play Area Private & confidential   Playsafe Ltd   www.playsafe.co.nz   info@playsafe.co.nz	32/106

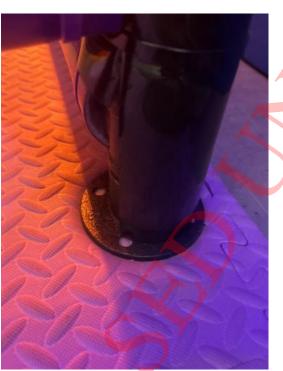
Photo 172	Photo 173	Photo 174	Photo 175	Photo 176	Photo 177	
Activity				Multipla	y Structure	
Issue				Missing faste	nings - Replace.	
				d highly recommer nge plates assume		
Risk Assessr	nent			Low/ M	edium Risk	
Recommend	lation			Re	ectify	
Finding 32	2				1 flagge	
Photos						
Photo 178	Photo 179	Photo 180				
Activity						
					Projecto	
Issue				No compliance issue with this - reported for fit and finish information only.		
Wiring shoul	d be tidied up an	d inaccessible		_		
Risk Assessr	ment			Low/ Medium Risk		
Recommend	lation			Rectify		
Finding 33					1 flagge	
Photos						
Photo 181	Photo 182	Photo 183	-			
2E046B17-3AC	<u>28-4E36-A4C6-F42D</u>	012BA993B-video.r	nov			
Activity					•
